MTE Consultants

December 15, 2020

MTE File No.: C48121-100

RE: Test Pit Investigation and Preliminary Slope Assessment
279 Hill Street, Port Stanley, Ontario

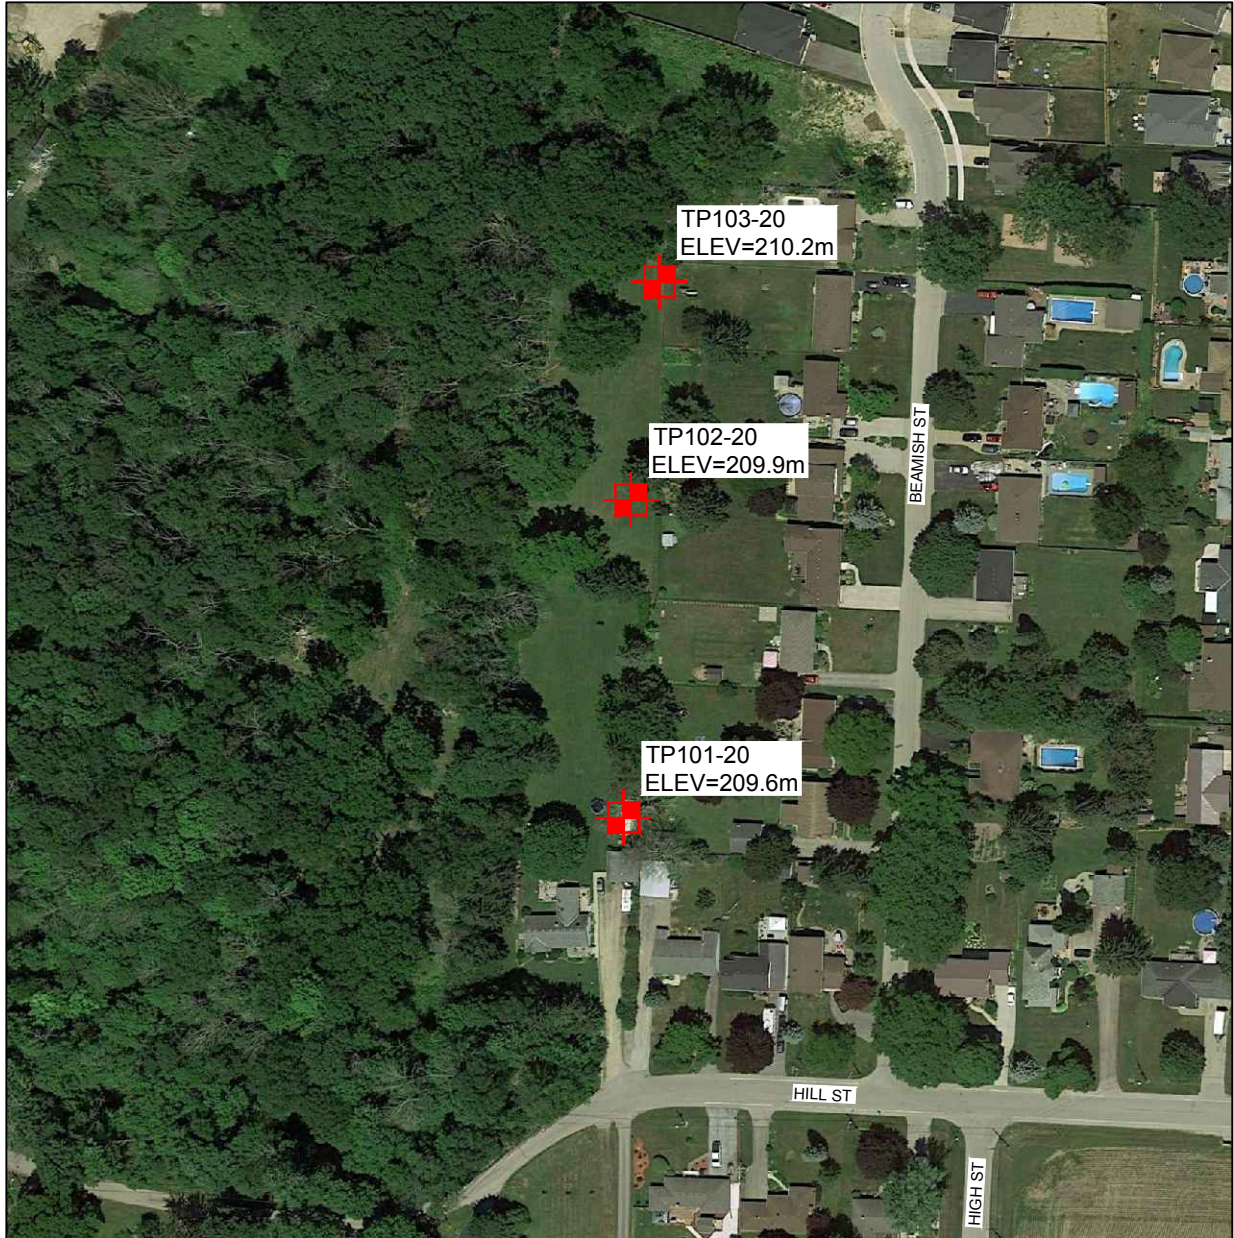
The purpose of the test pits was to inspect the native soils at the site and determine if the native soils were suitable for bearing of the proposed buildings. Three test pits were excavated at the site at locations designated by Cyril J. Demeyere Limited (CJDL) as shown on Figure 1 and the test pitting was witnessed by a representative of our geotechnical engineering staff.

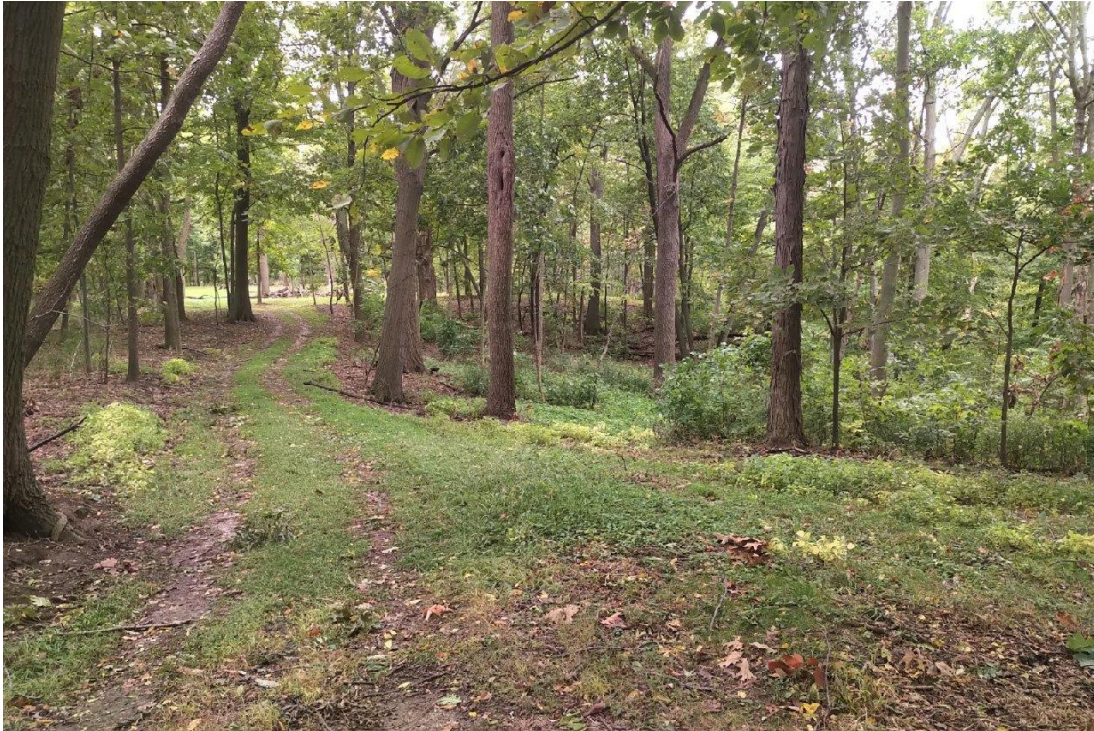
Photograph 1 – General view of the site looking south with the top of slope to the west.

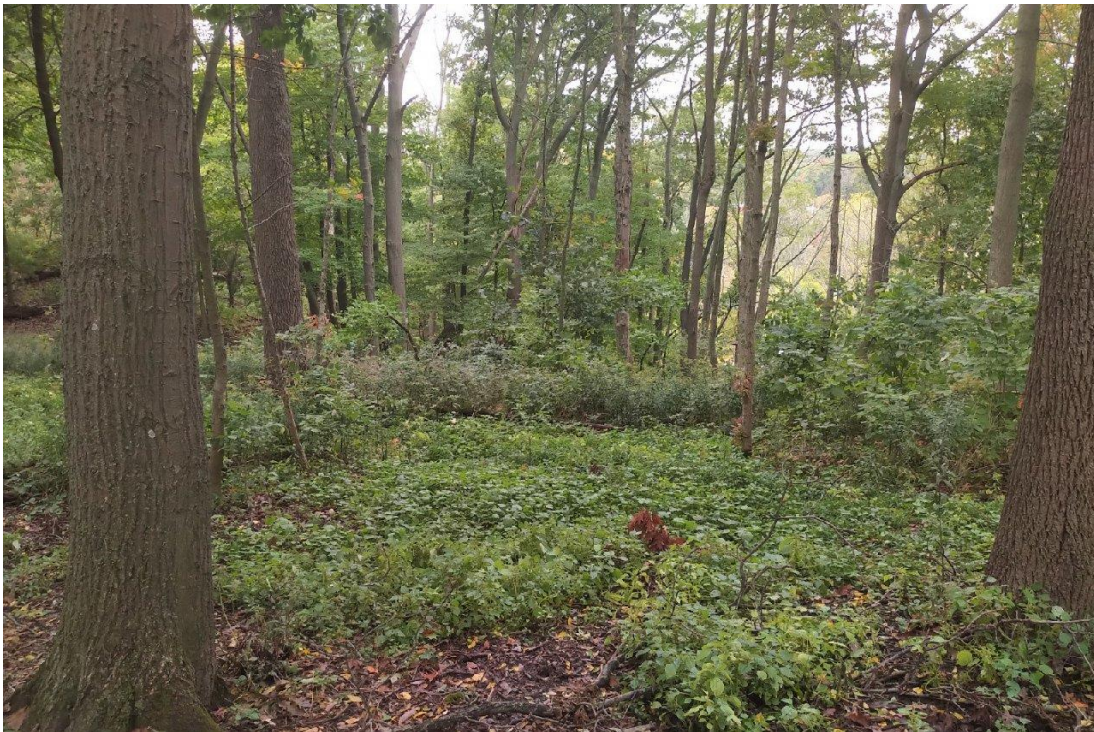
Photograph 2 – Looking west from top of slope.

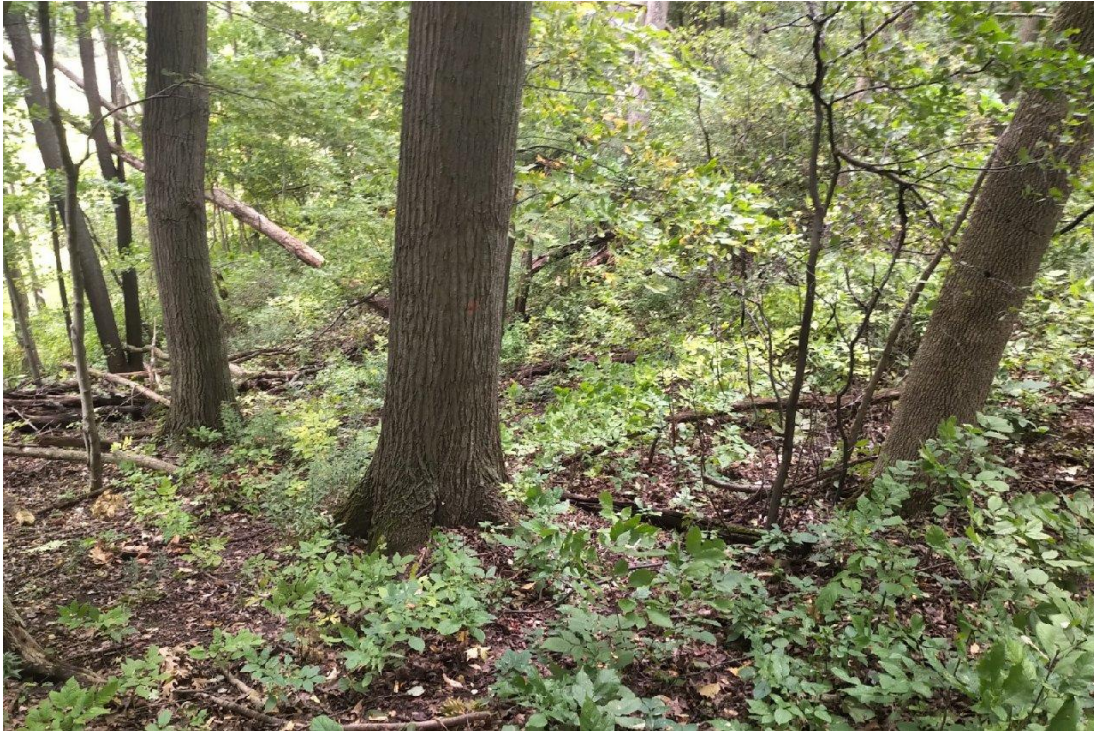
Based on the visual observations on site and the preliminary topographical information, there are no signs of slope instability for the overall slope to the west of the property at 279 Hill Street in Port Stanley, ON. Based on the preliminary slope assessment, a setback allowance will consist of an access allowance setback of 6 m from the top of the slope. All drainage should be directed away from the top of the slope to suitable receptors at the roadway. No fill materials should be placed on the face or at the top of the slope during or after construction. A footing subsoil inspection is recommended prior to placing concrete for the foundations of any proposed structures to verify the subsoil conditions.

Photograph 3 – Looking west from mid slope. Note vertical trees and vegetation.

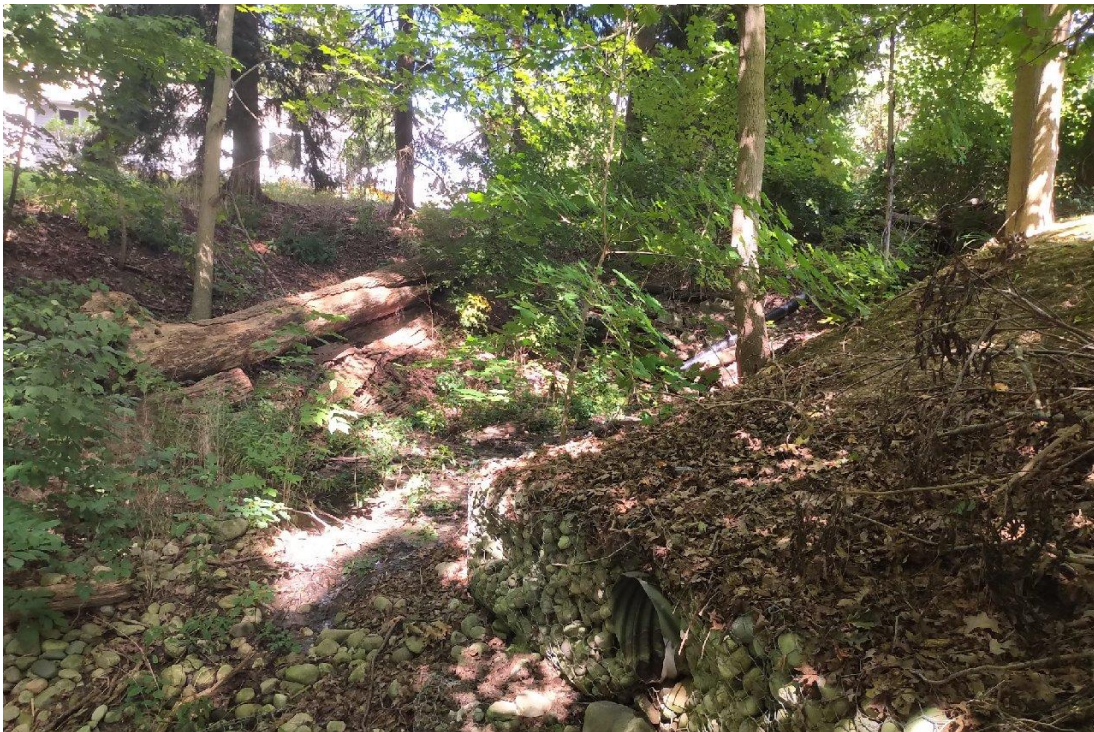
Photograph 4 – Looking north from toe of ravine slope near driveway to property at 279 Hill Street. Note drainage pipe and gabion baskets to the east.

A small portion of the ravine valley to the west of the driveway to the property at 279 Hill Street is proposed to be filled to allow access to the development. The fill required for the area could be up to 12 m in height. Any fill placed in the valley should be properly benched into the existing slopes as per OPSD 208.010. The slope of the fill should be at a maximum inclination of 3 horizontal to 1 vertical using native soils as backfill material. If granular soils, such as Granular B Type II, are used for backfill, an inclination of 2 horizontal to 1 vertical can be used for the valley area. All fill materials should be properly compacted in maximum 400 mm thick loose lifts.
