TREE ASSESSMENT AND PROTECTION

**Doug Tarry Homes Ltd.
St. Thomas**

June 2021

APPENDIX 5: Tree Hazard Assessment for Northern Ravine

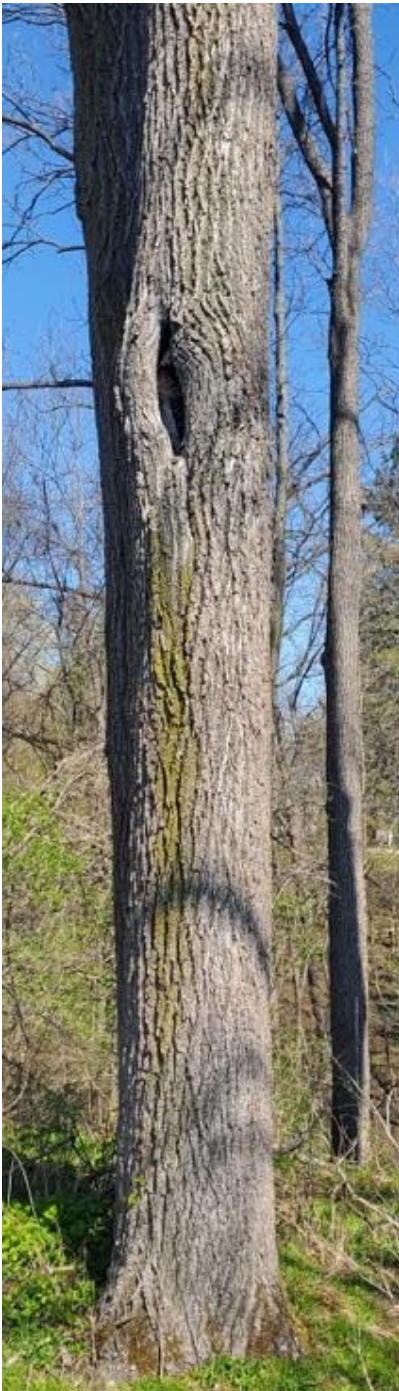
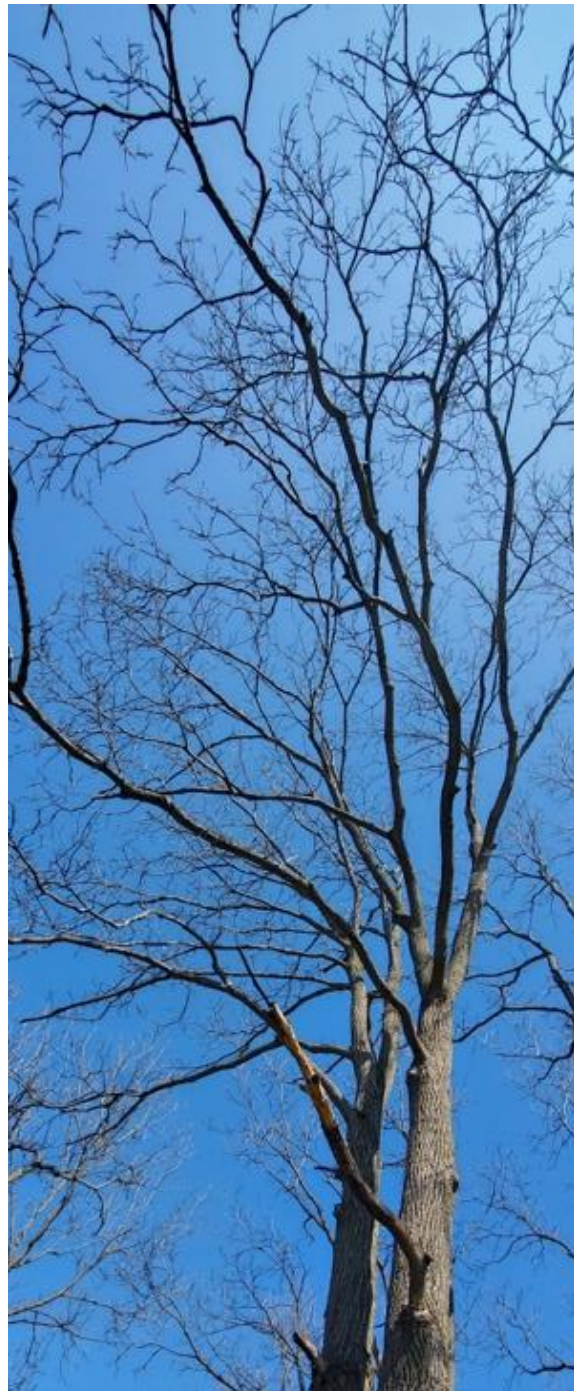
Tree ID 1: Trunk

Tree ID 1&2: Black Walnut (*Juglans nigra*).
Retain. 3 m from dripline CRZ.

DBH: 1: 50.8 cm 2: 50.8 cm

Comments: Canker on trunk which is compartmentalized. Dead branches in lower canopy. Potentially hazardous dead limbs that should be removed.

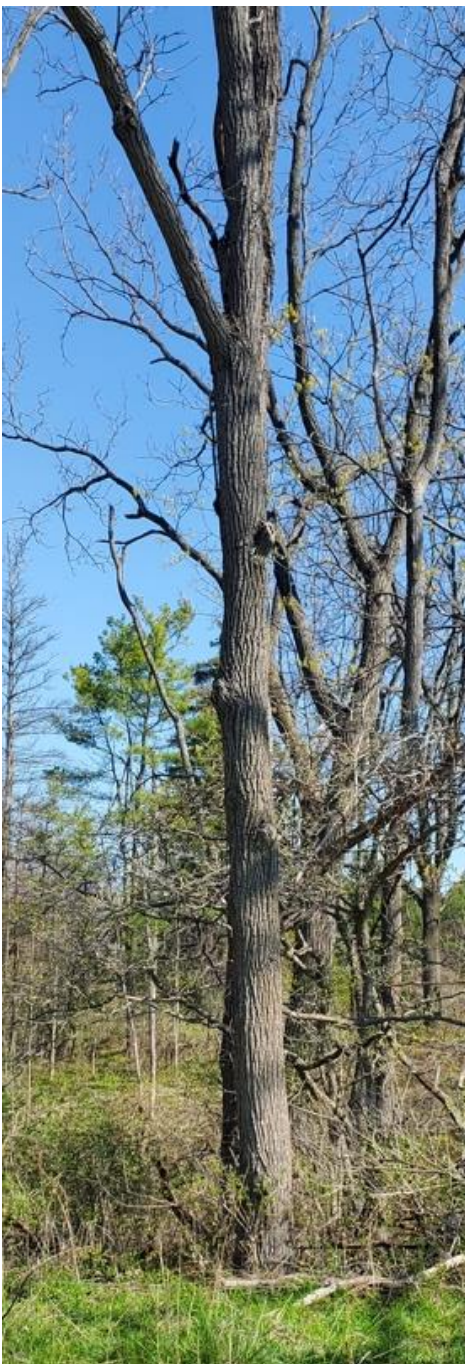
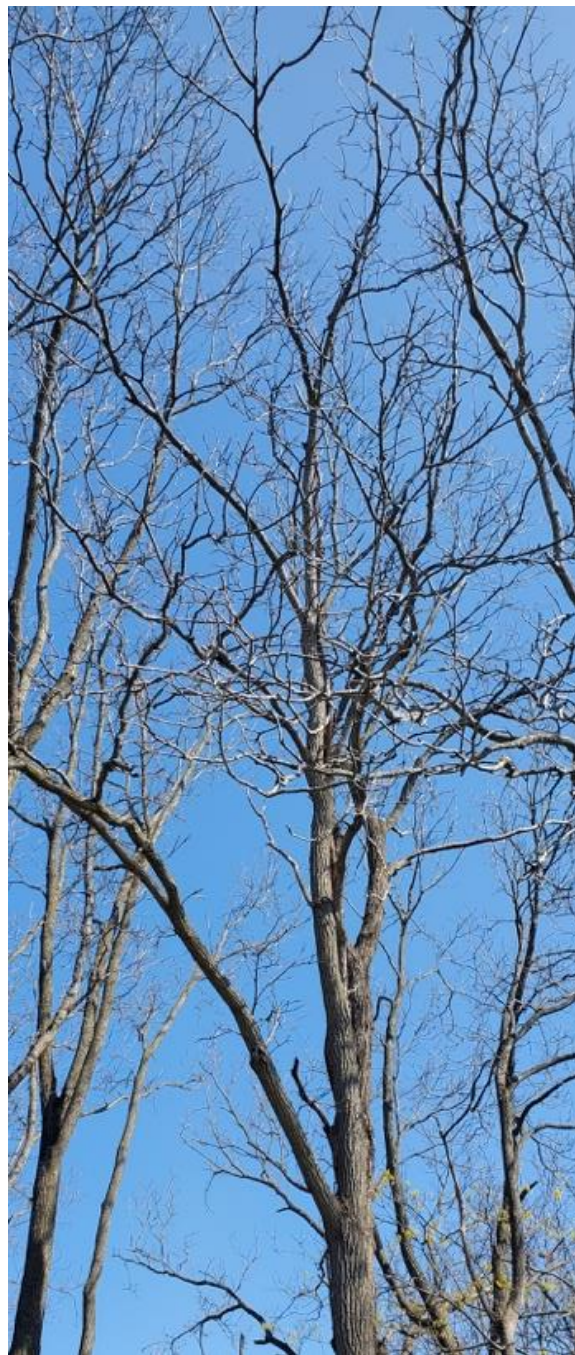
Tree ID 3: Trunk

Tree ID 3: Black Walnut (*Juglans nigra*). Retain.
CRZ 3 m from dripline.

DBH: 30.48 cm

Comments: N/A. Trimming of lower branches in the clearing and grubbing phase.

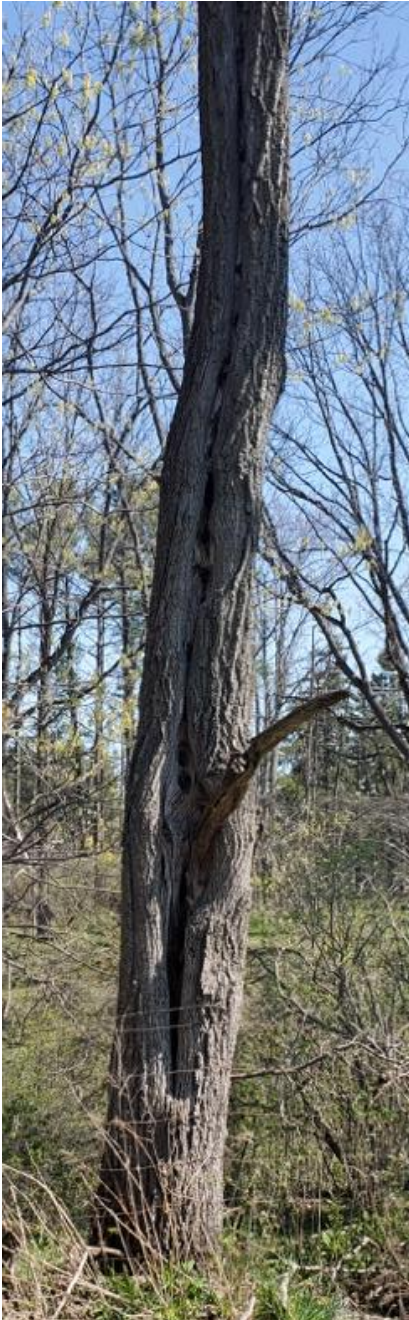
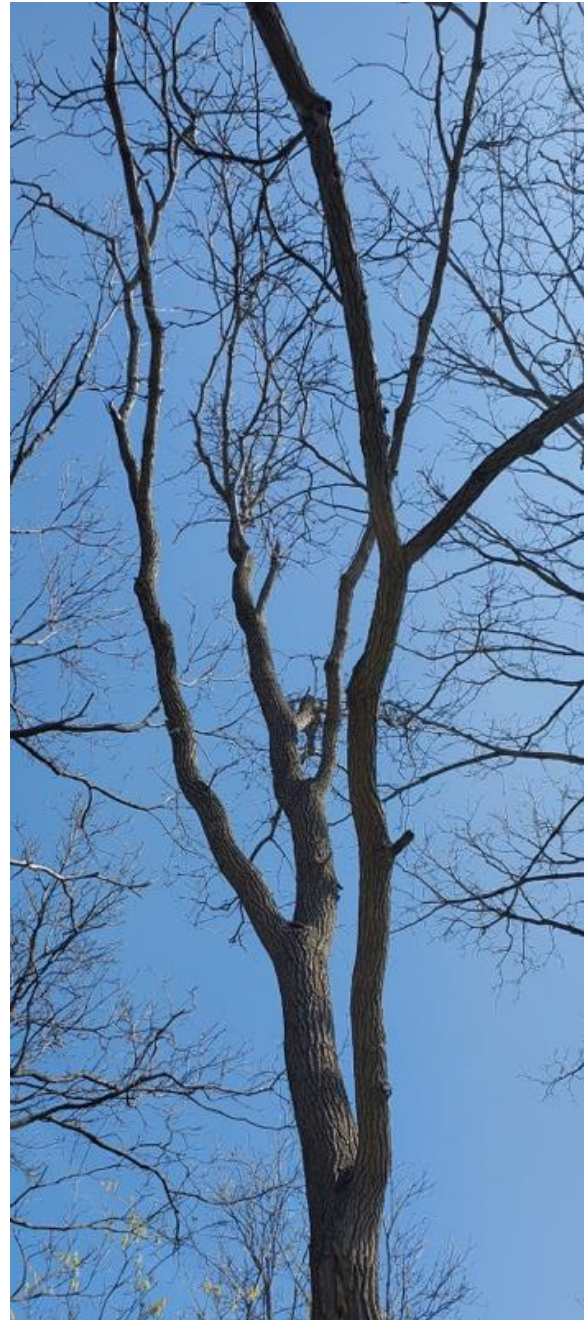
Tree ID 4: Trunk

Tree ID 4: Black Walnut (*Juglans nigra*).
Remove.

DBH: 50.8 cm

Comments: Hazardous. Linear canker up trunk 6 m in length.

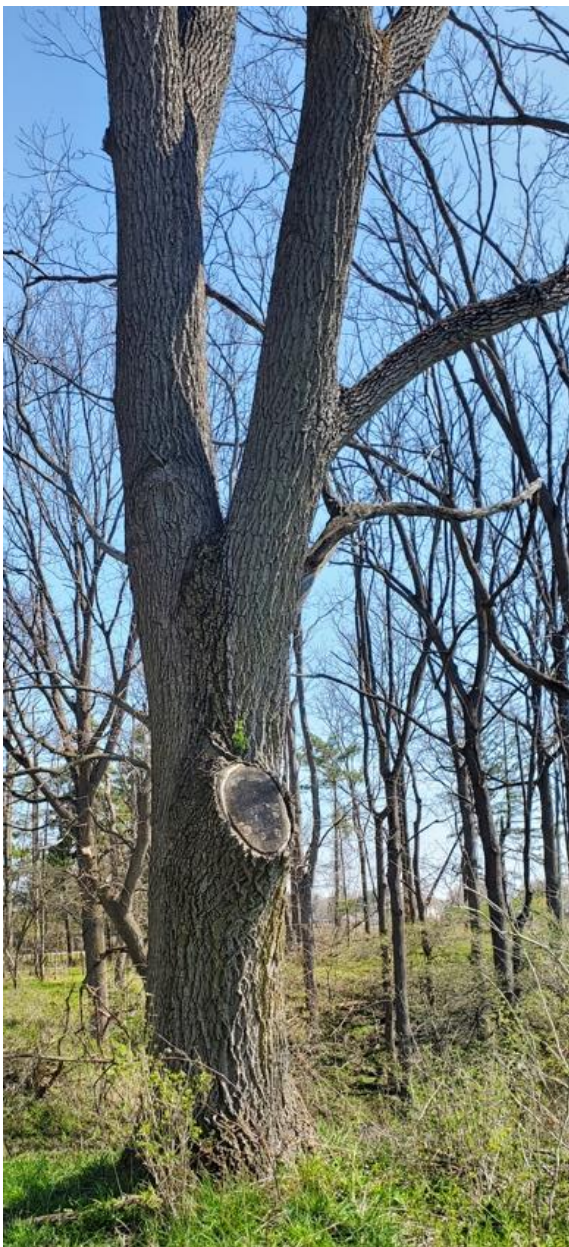
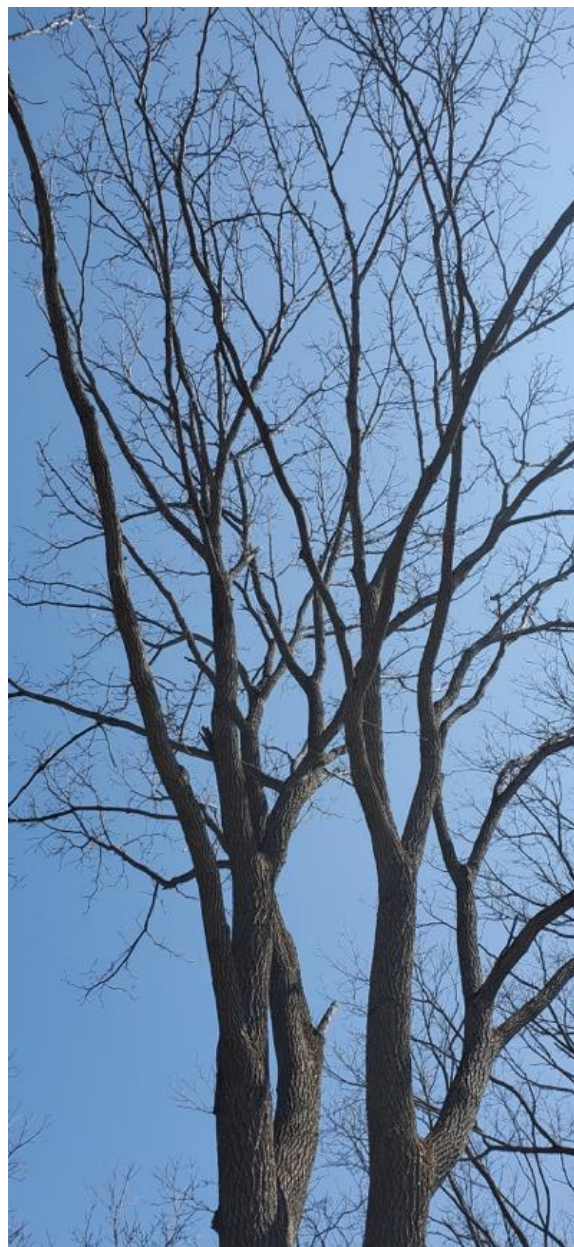
Tree ID 5: Trunk

Tree ID 5: Black Walnut (*Juglans nigra*).
Remove.

DBH: 76.2 cm

Comments: Pruning of large (25cm diameter) limb, codominant stems at 3 m, codominant branches, epicormic branches on lateral lower limbs.

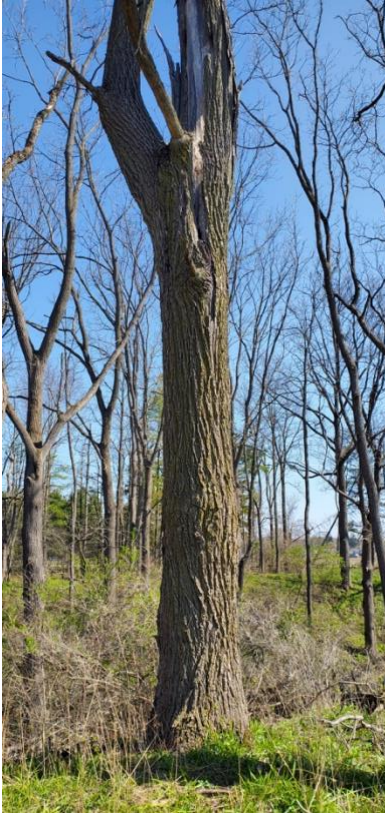
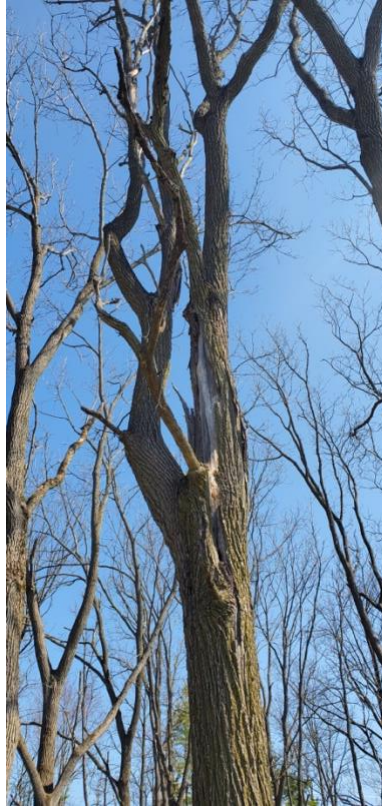
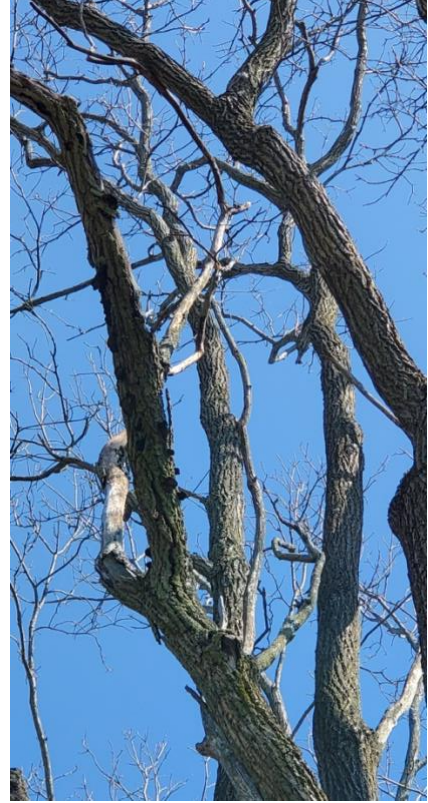
Tree ID 6: Trunk

Tree ID 6: Black Walnut (*Juglans nigra*).
Remove.

DBH: 76.2 cm

Comments: Bark peeling, dead wood, structural aberrations, codominant stems, mid trunk and woodpecker holes.

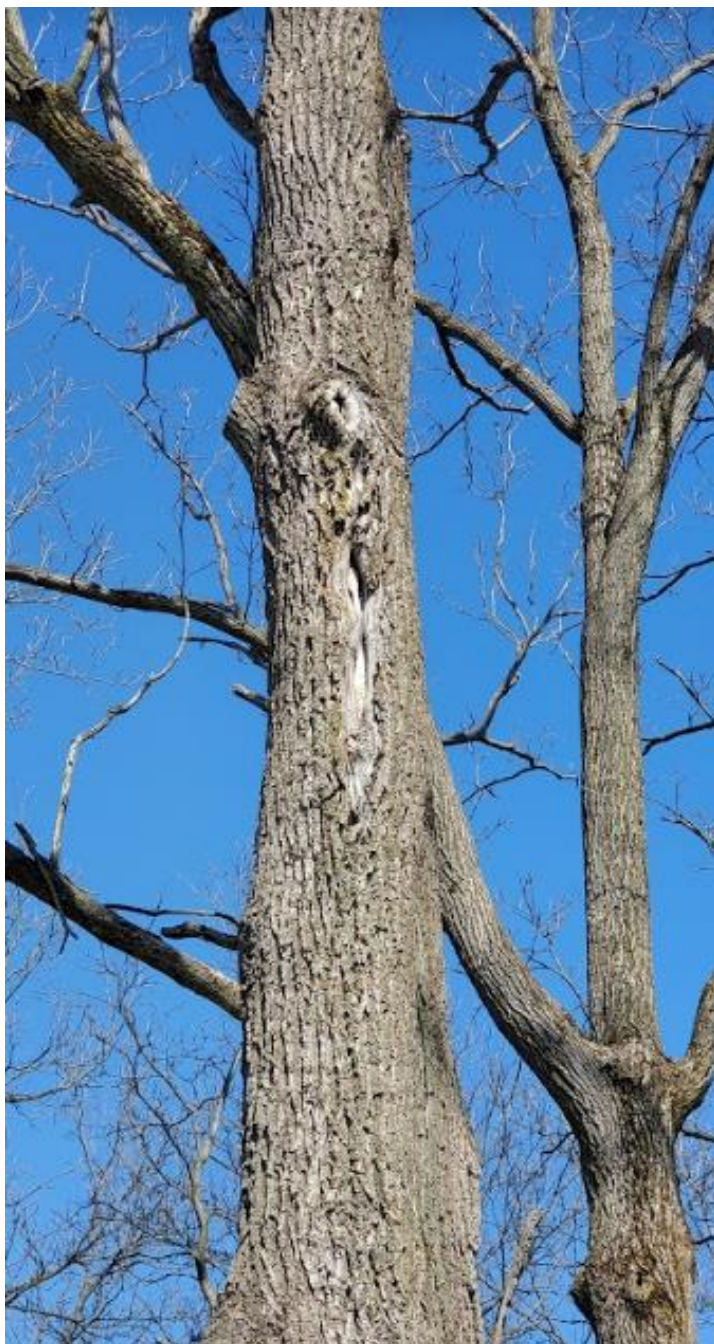
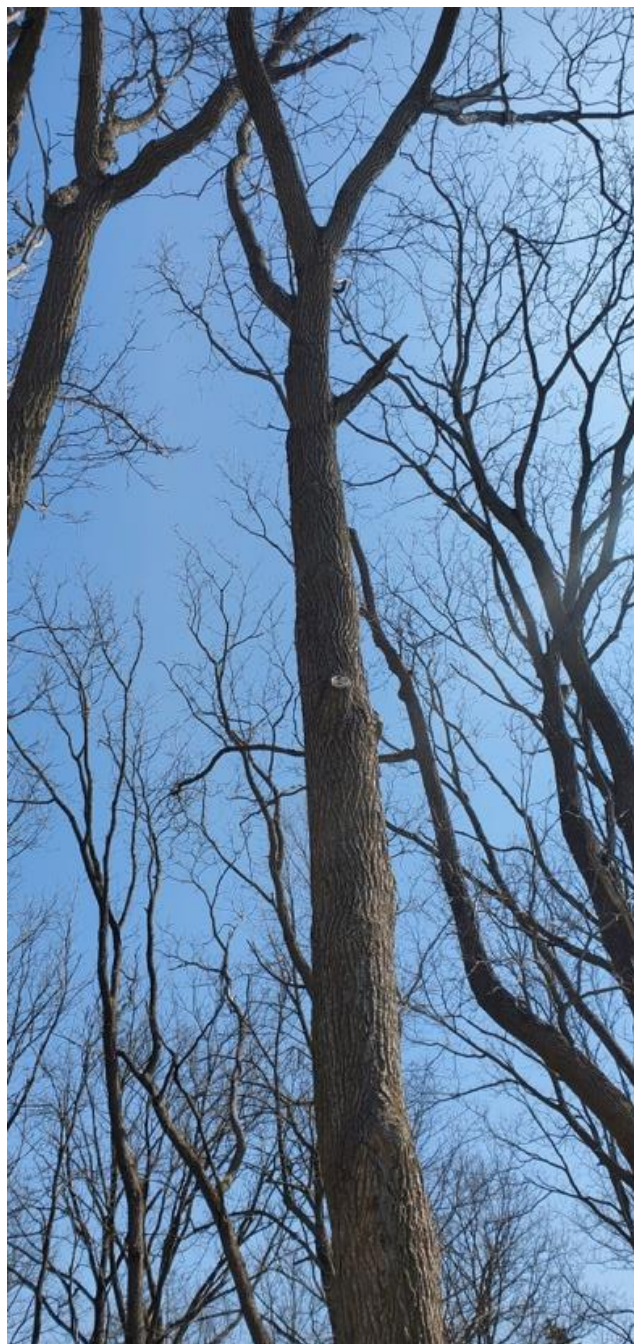
Tree ID 7: Trunk

Tree ID 7: Black Walnut (*Juglans nigra*).
Remove.

DBH: 40.3 cm

Comments: Sheared lateral limbs
suggesting the tree is internally structural
compromise.

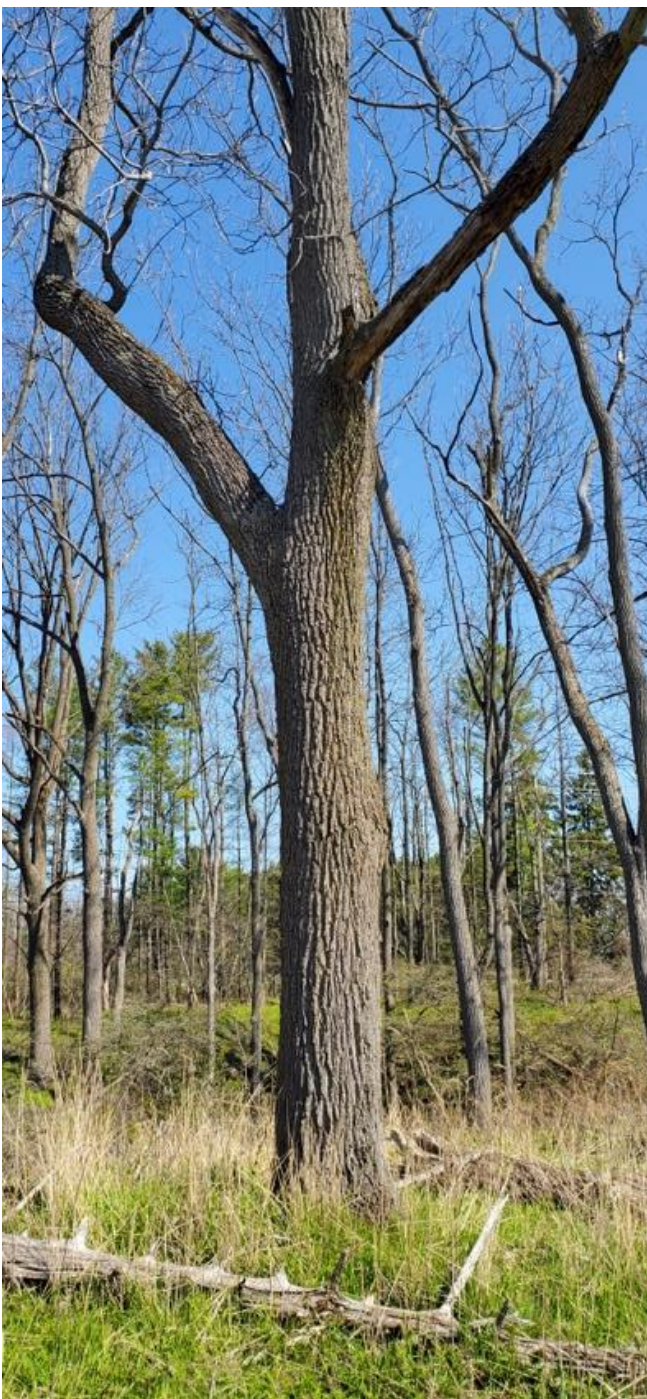
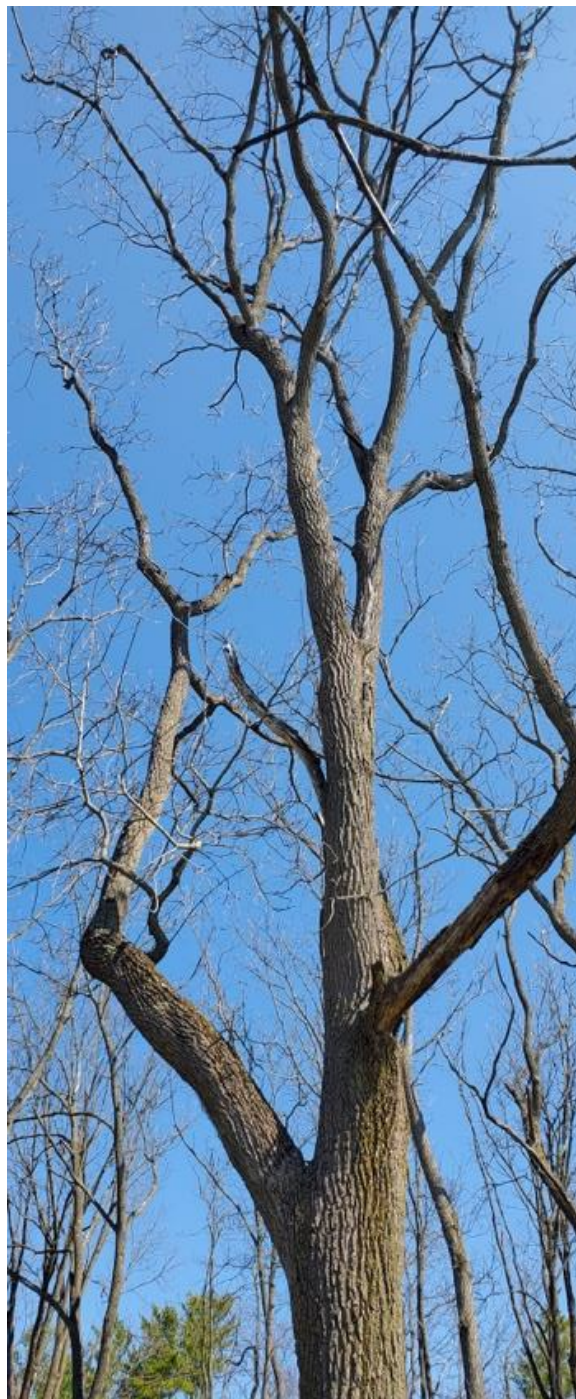
Tree ID 8: Trunk

Tree ID 8: Black Walnut (*Juglans nigra*).
Remove.

DBH: 60.6 cm

Comments: Irregular growth above the angle of attachment. Other lateral limb exhibits rotting.

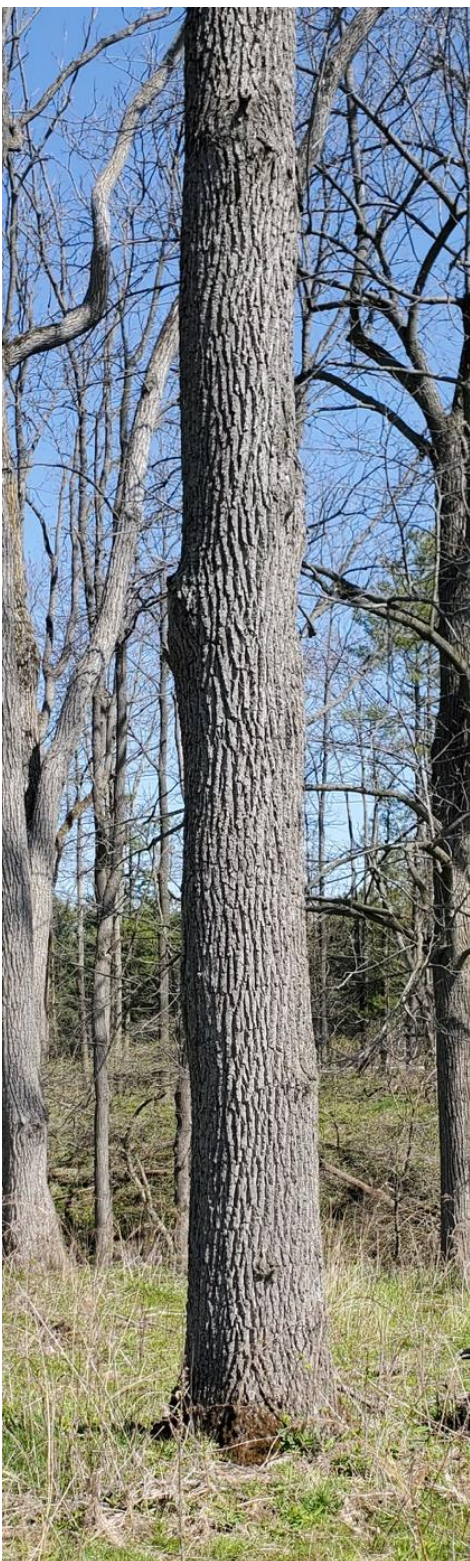
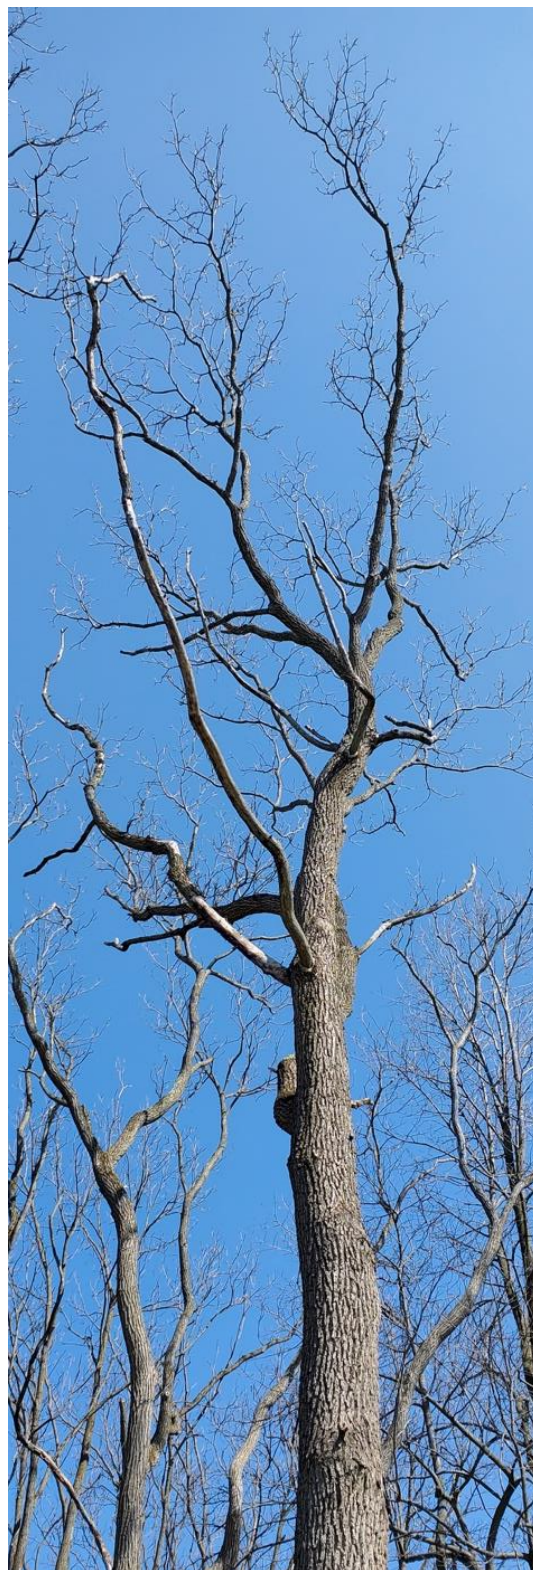
Tree ID 9: Trunk

Tree ID 9: Black Walnut (*Juglans nigra*).
Remove.

DBH: 52.3 cm

Comments: Reduced canopy and lots of
dead lower limbs.

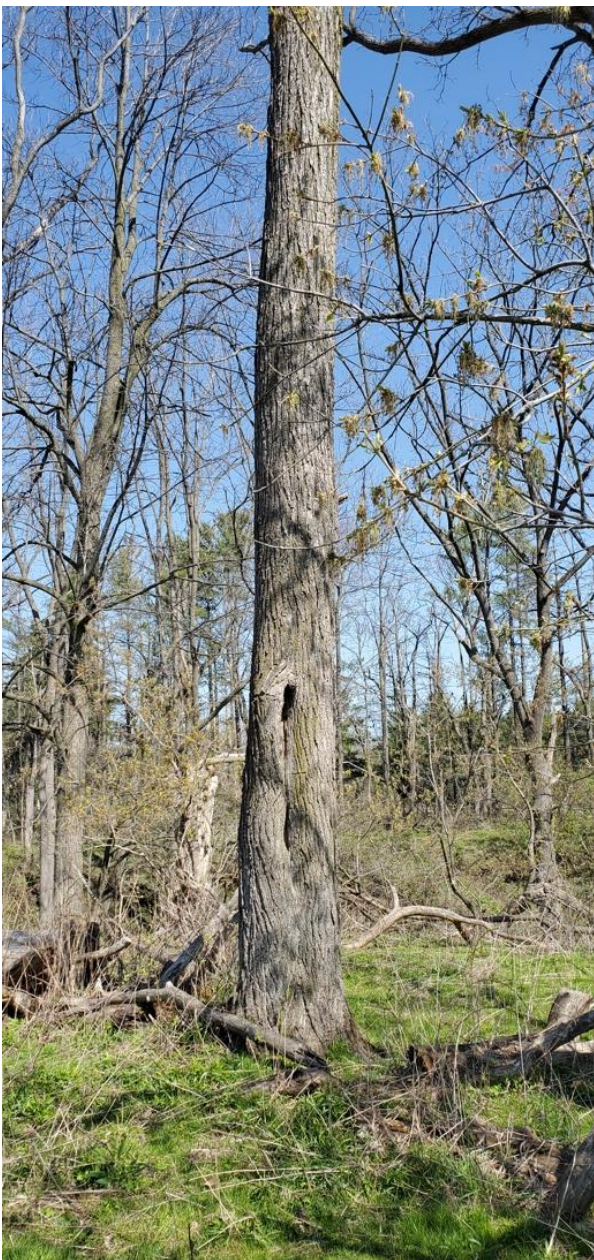
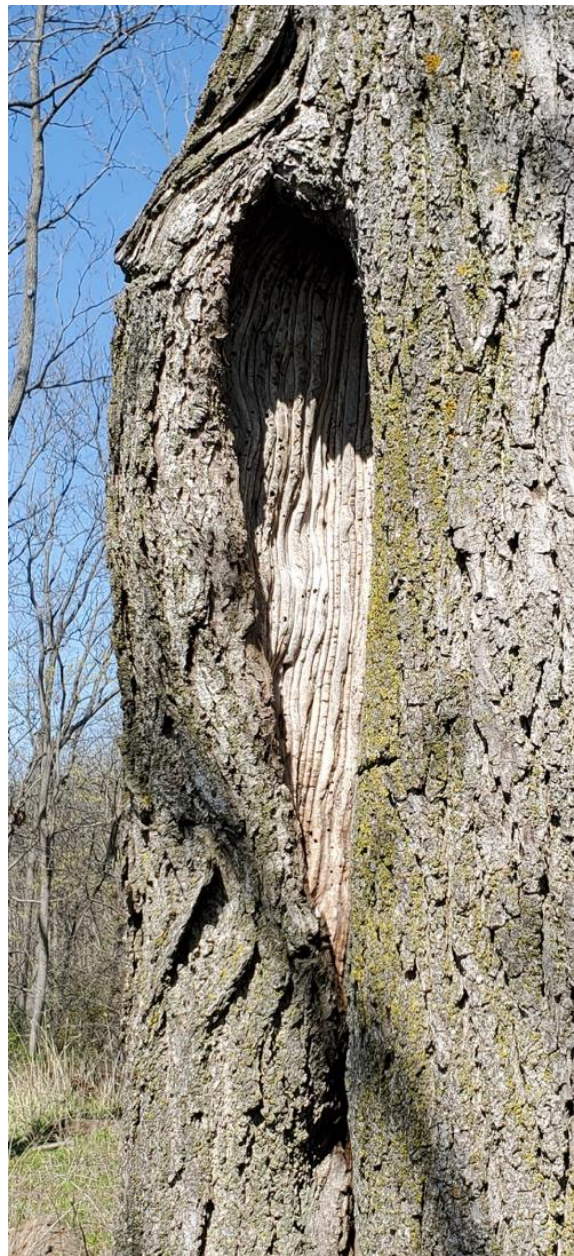
Tree ID 10: Trunk

Tree ID 10: Black Walnut (*Juglans nigra*).
Remove.

DBH: 63.2 cm

Comments: Large (1 m long x 30 cm wide) canker on trunk improperly healed, Codominant stems at 8 m.
