MTE Consultants

August 8, 2025

MTE File No.: C62953-001

**RE: Preliminary Slope Assessment  
46498 Sparta Line, Sparta, Ontario**

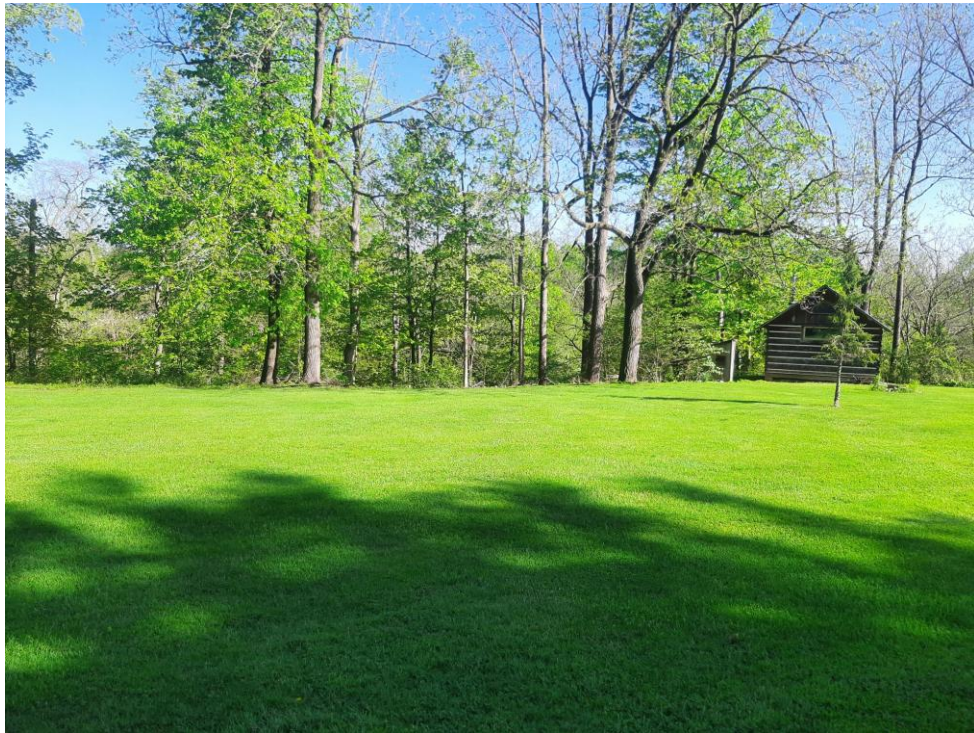
Photograph 1 – General view of the slope looking north from behind existing building.

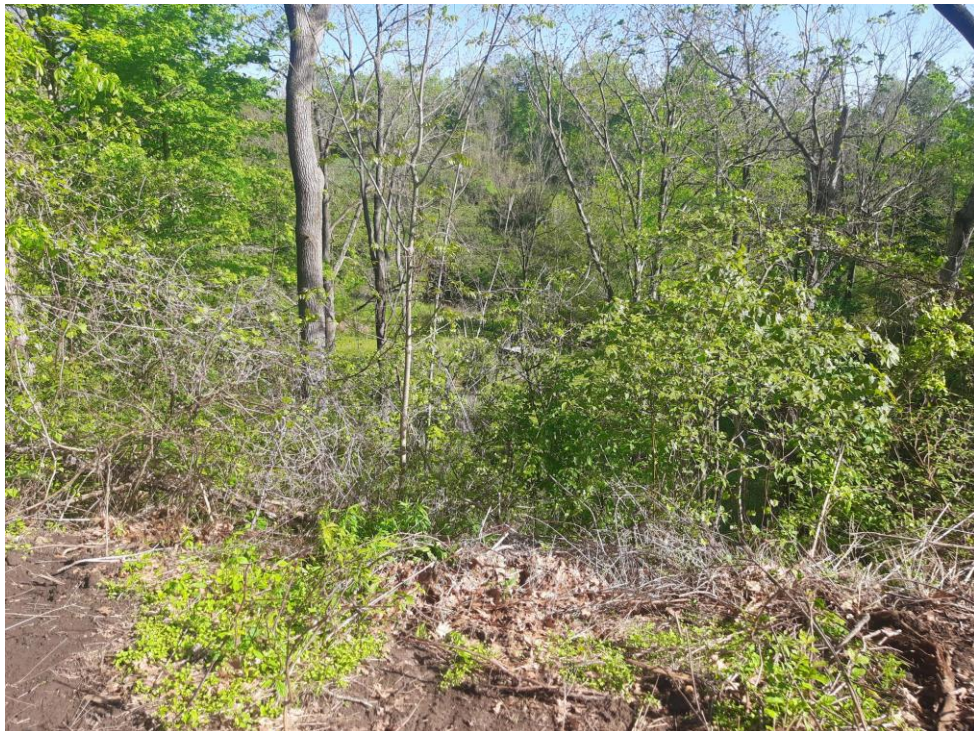
Photograph 2 – Looking north from top of slope.

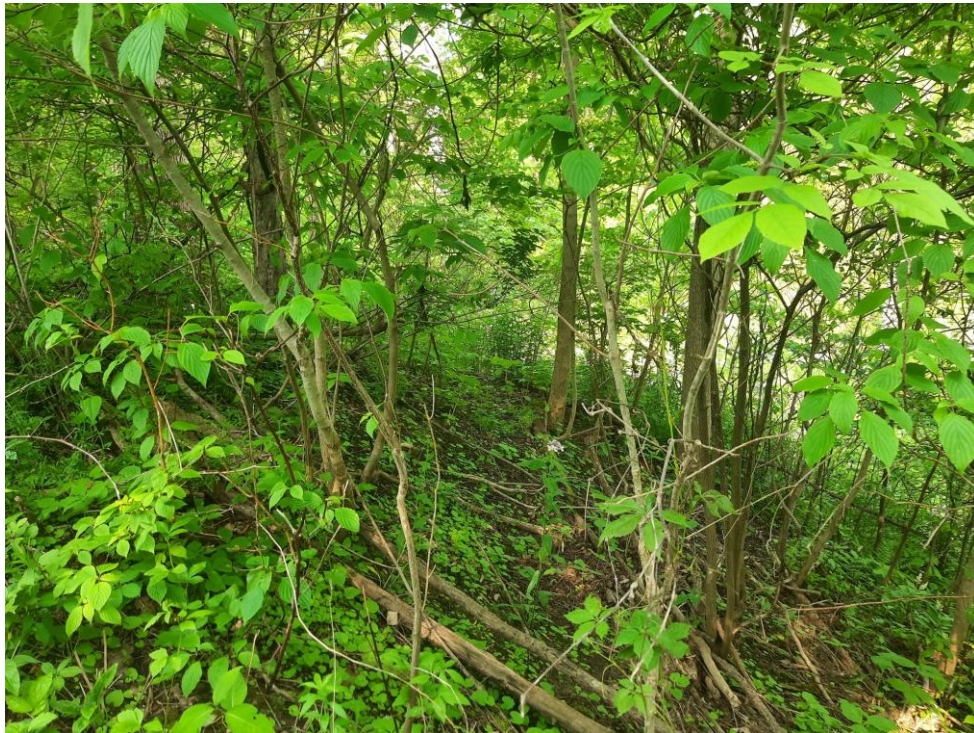
Photograph 3 – Looking west from middle of slope. Note full vegetation.

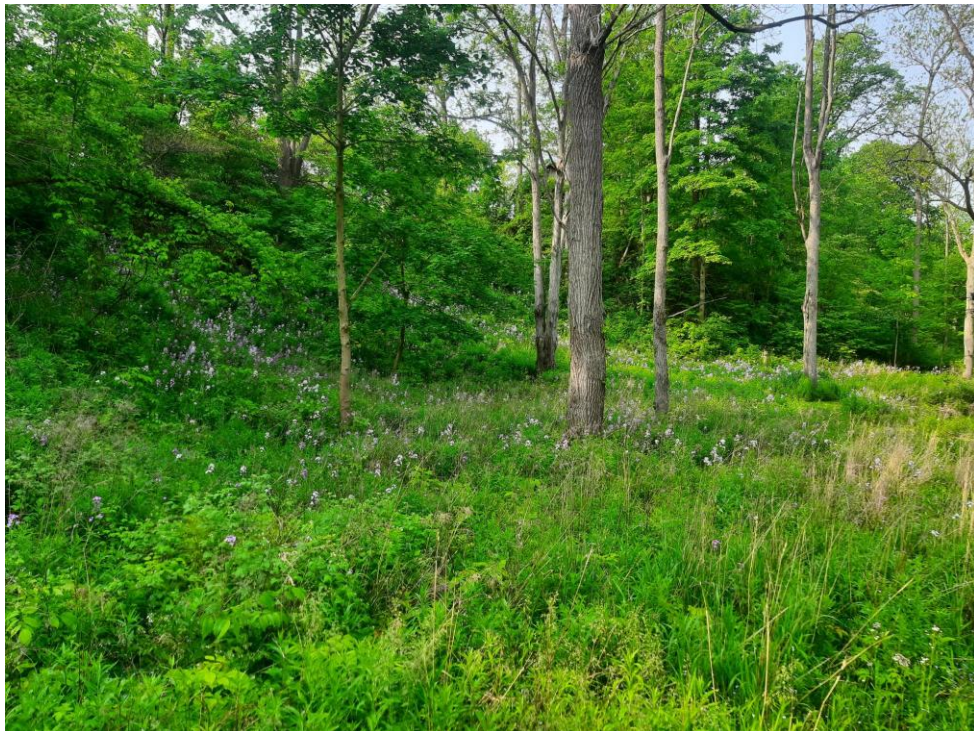
Photograph 4 – Looking southwest from toe of slope.

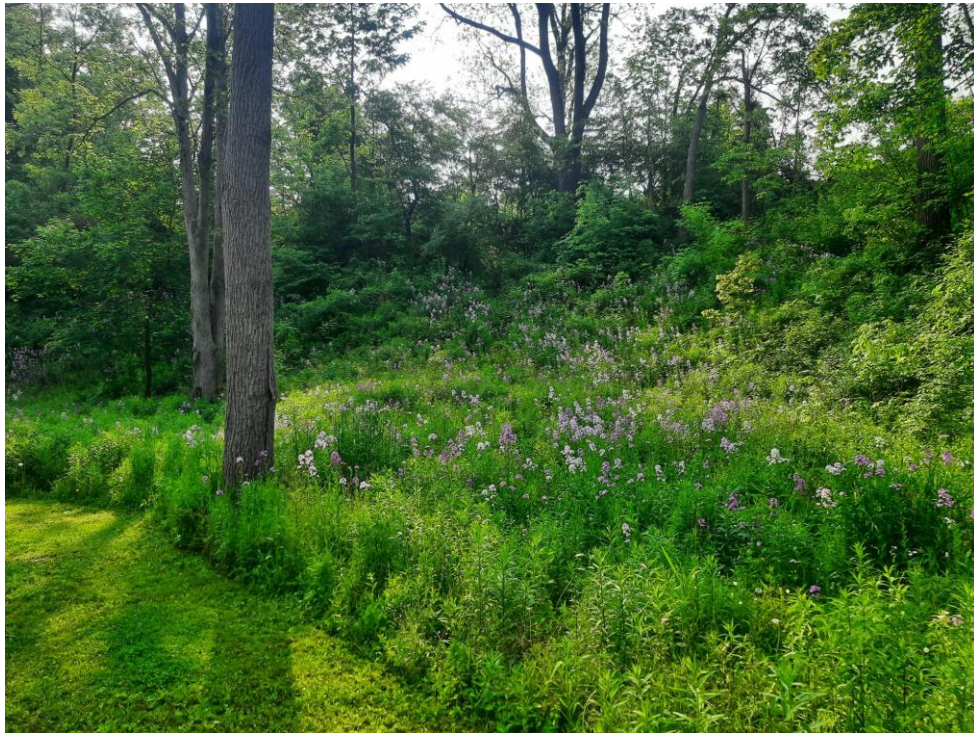
Photograph 5 – Looking southeast from toe of slope.

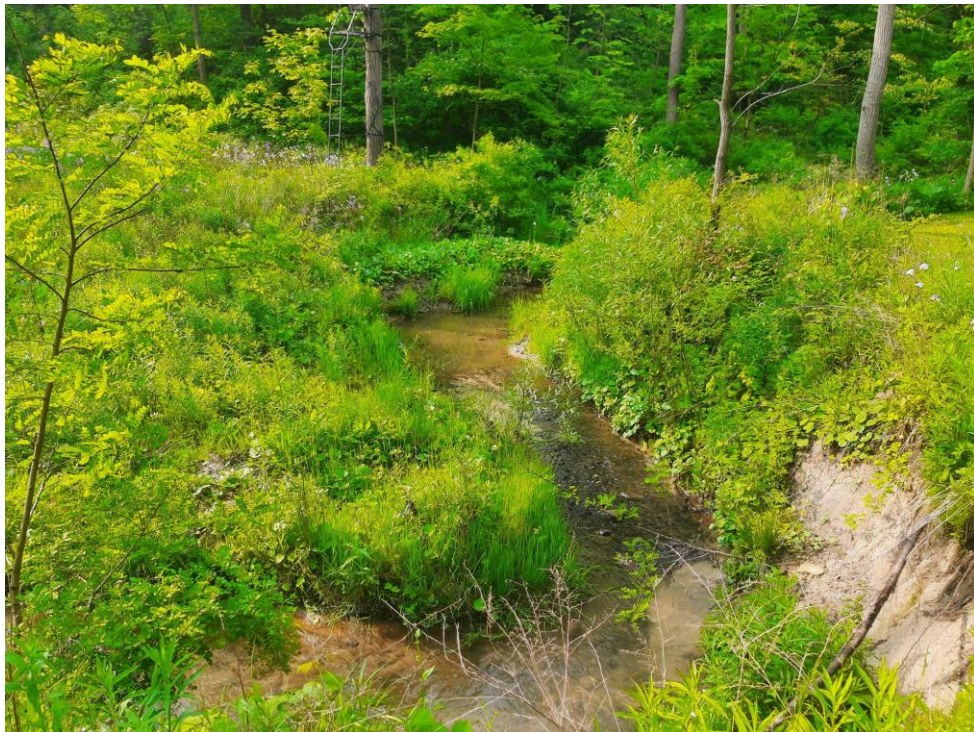
Photograph 6 – Looking west along creek near toe of slope.
