Wastell Homes

Slope Assessment

Project Name George Street, Port Stanley

Project Number LON00014790-slope

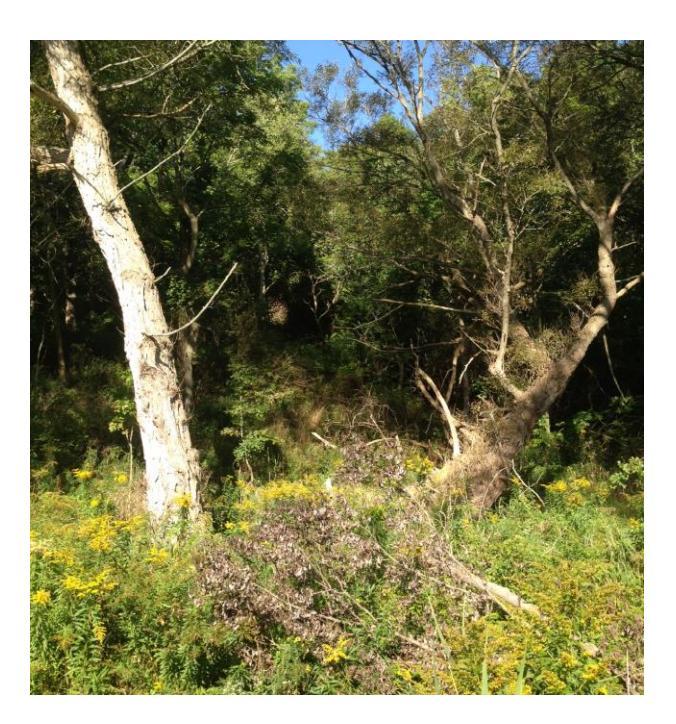
Photograph 1:

Based on the rating system indicated in the "Slope Stability Rating Chart" prepared by the Ontario Ministry of Natural Resources, the slope rating at the site was calculated to range from 32 to 34 at Cross Sections A-A', B-B' and C-C'. The slope ratings indicate moderate for slope instability. The slope rating charts are provided in **Appendix B**. Selected photos at A-A', B-B' and C-C' section locations are presented below.

From the toe of the slope looking towards the crest of the slope at Section A-A'.

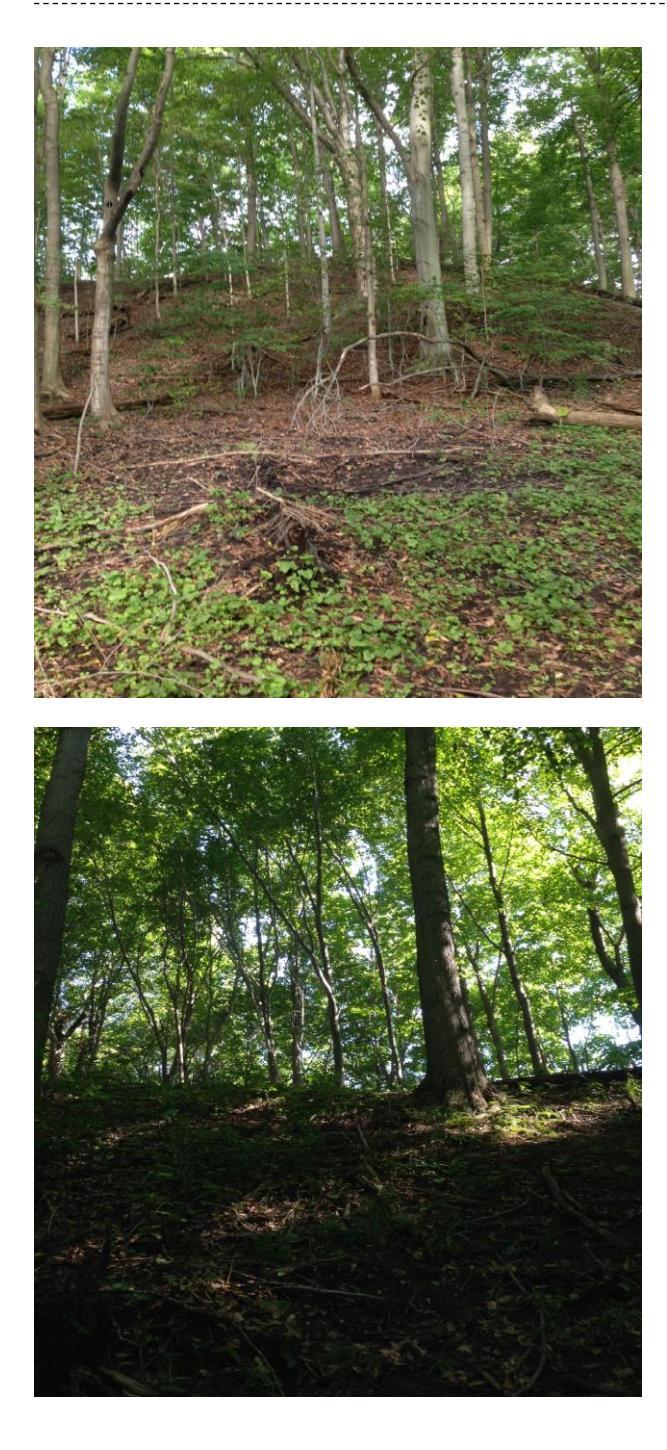
Photograph 2:

From the mid of the slope face looking towards the crest of the slope at Section B-B'.

Photograph 3:

Looking towards the crest at the base of the slope at Section C-C".

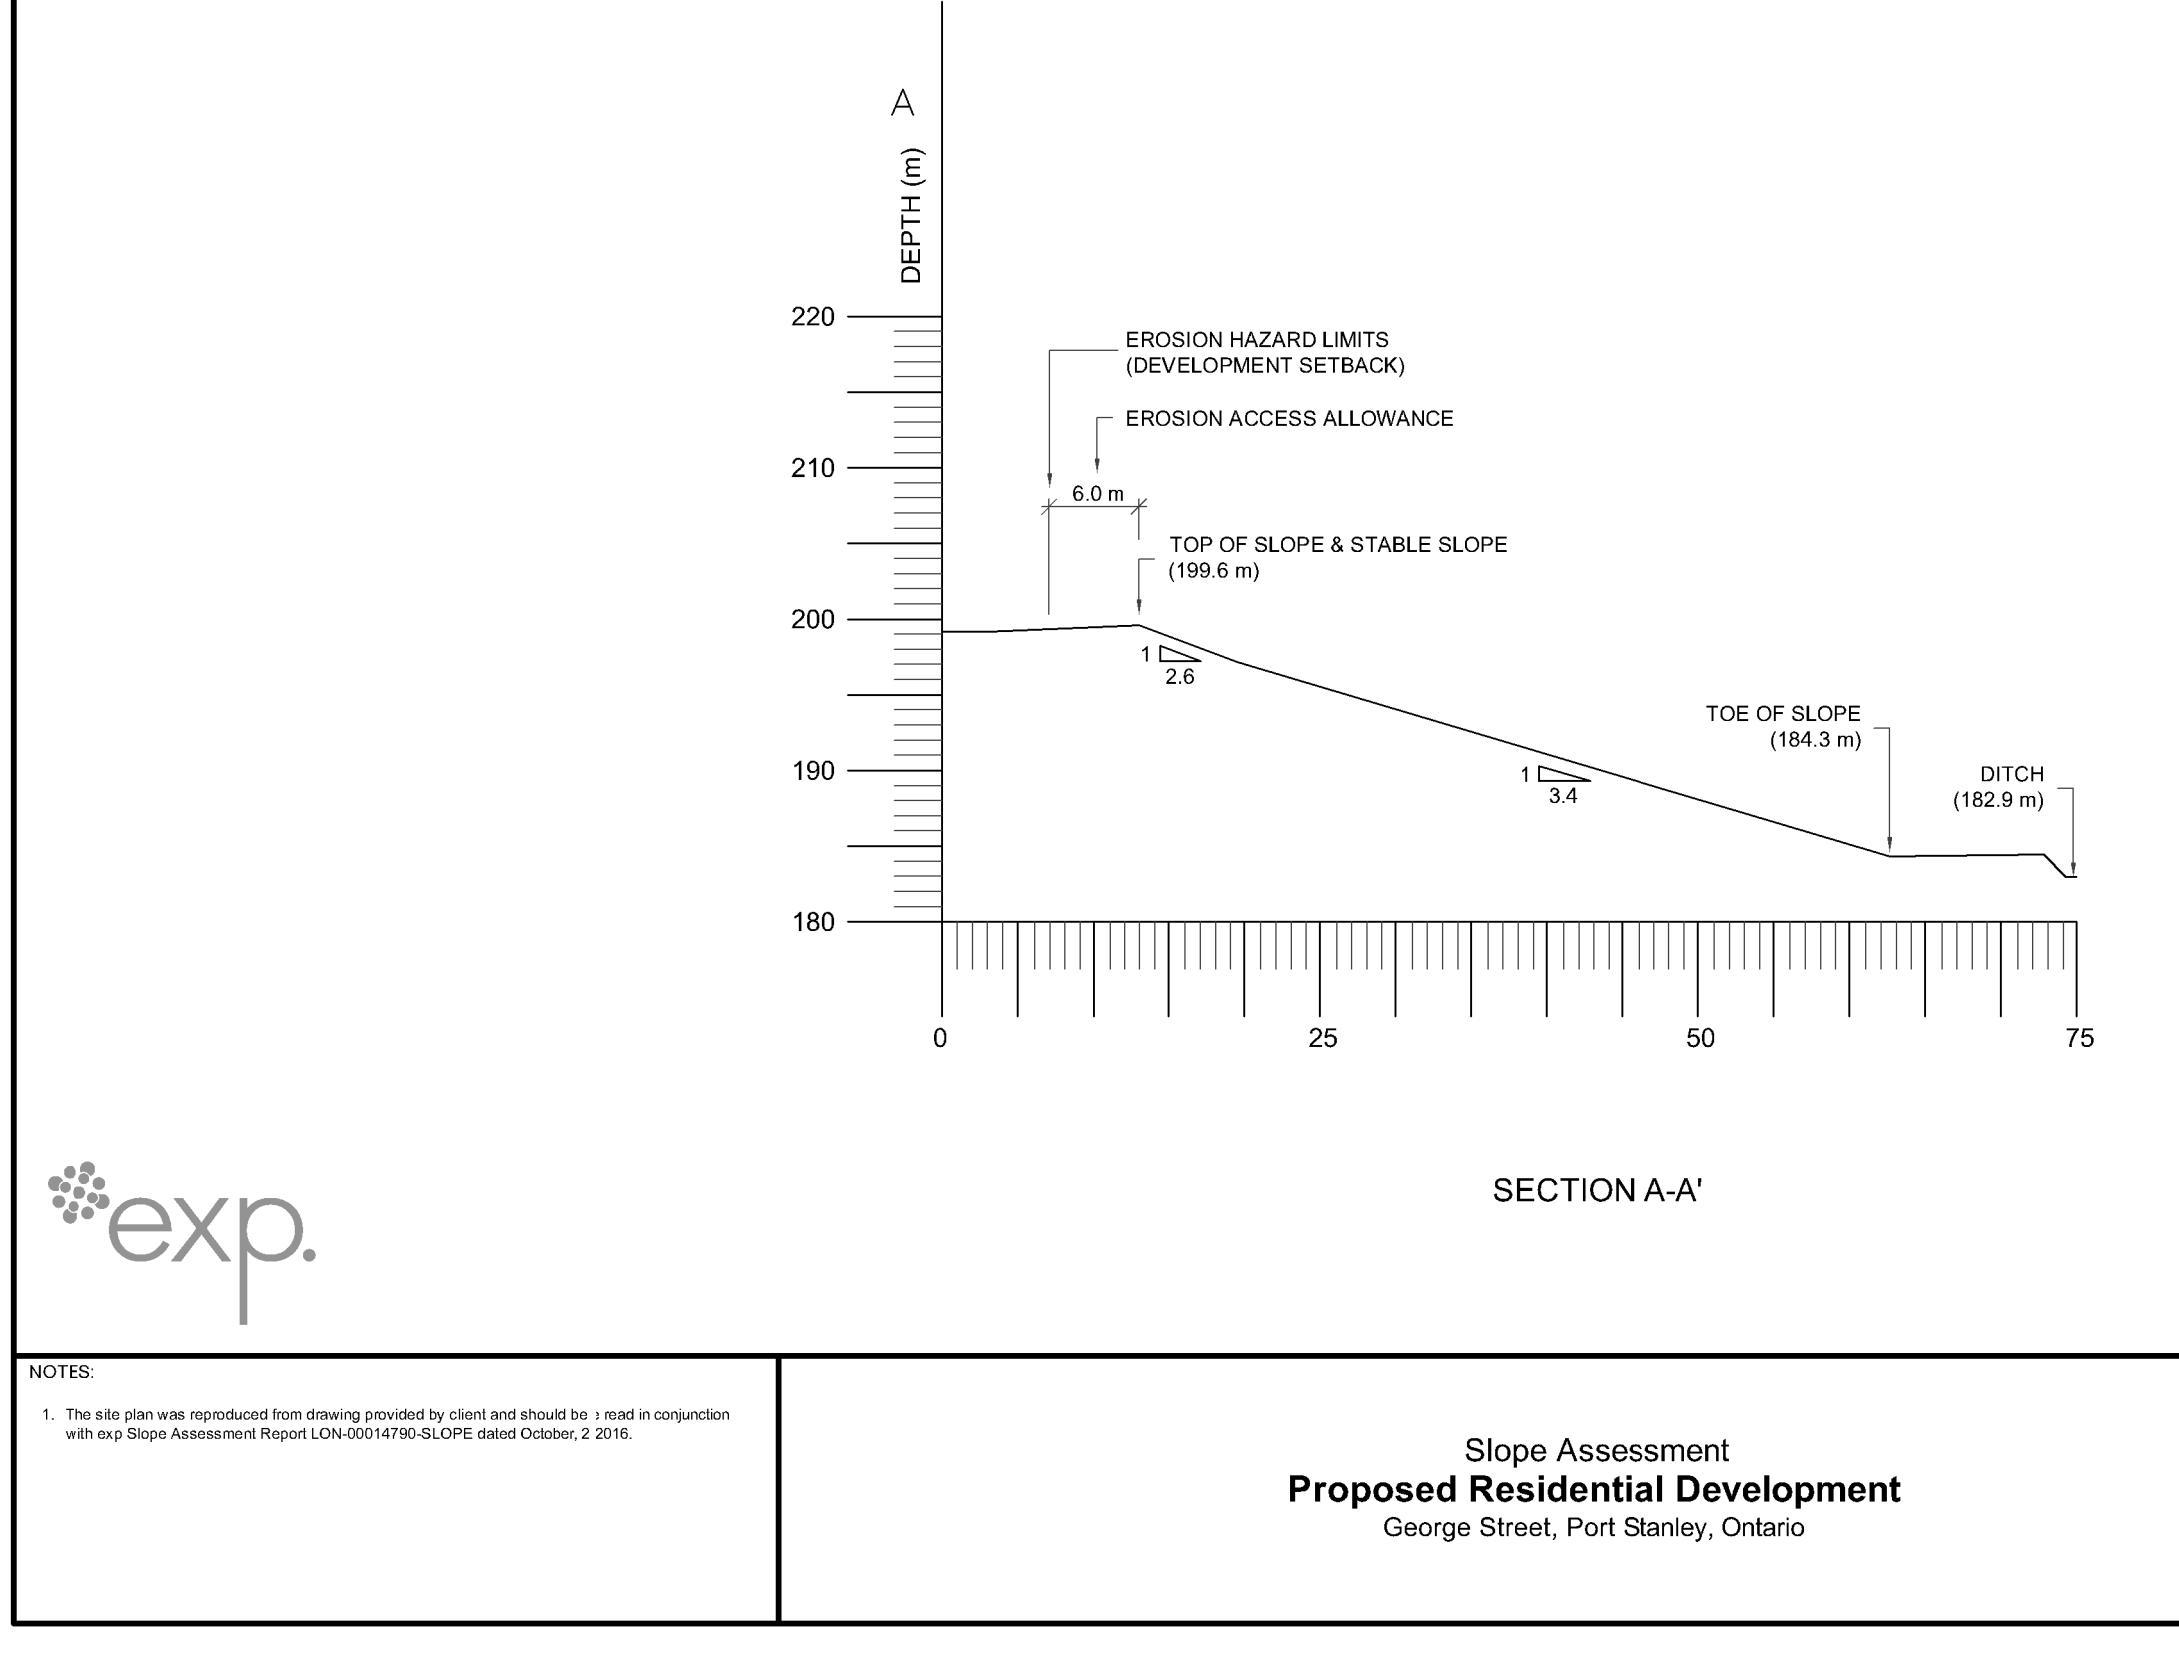
CLIENT	387476 Ontari	o Ltdl.		
TILE	SECTION A-A			
DRAWN BY	J.T.	RE	emewed by I.S.	
*e	xp.	15701 Robin's	exp Services Inc. : Hill Road, London, ON, N5V 0A5	
DATE Ju	ine 2017	scale 1:500	PROJECT NO. LON-00014790-GE	^{DWG.} 202

Three cross sections A-A', B-B' and C-C' were drawn at steepest locations across the slope from south to north. The three cross section locations are shown on **Drawing No. 1** and the profiles provided on Drawing Nos. 2, 3 and 4. Slope gradient at section B-B' is steeper than other sections; therefore, slope analyses were only undertaken at this section' by computer methods utilizing the Slope/W computer program for selected slope profile. The failures at cross section B-B' were shallow to medium depth rotational failure with factor of safety of 1.7 to 1.8. These findings were in general agreement with observations of well vegetated slope which is beneficial for protection against landslides activities. The slope is considered stable. Therefore, no stable slope allowance is required at this section and for entire area.

Cross Section	Toe Erosion Allowance, m	Stable Slope Allowance, m	Erosion Access Allowance, m	Erosion Hazard Limit (Development Setback) from Top of Slope, m
A-A'	0	0	6	6
B-B'	0	0	6	6
C-C'	0	0	6	6

The Erosion Access Allowance as specified in Section 3.4 of the MNR Technical Guide is a distance of 6 m from the top of the slope. This allowance is required in order to provide access for repairs to the slope from the top of the slope. **Exp** recommends that a distance of 6 m for the erosion access allowance be provided on the table land. No permanent structures should be constructed within the 6 m of the erosion access allowance.

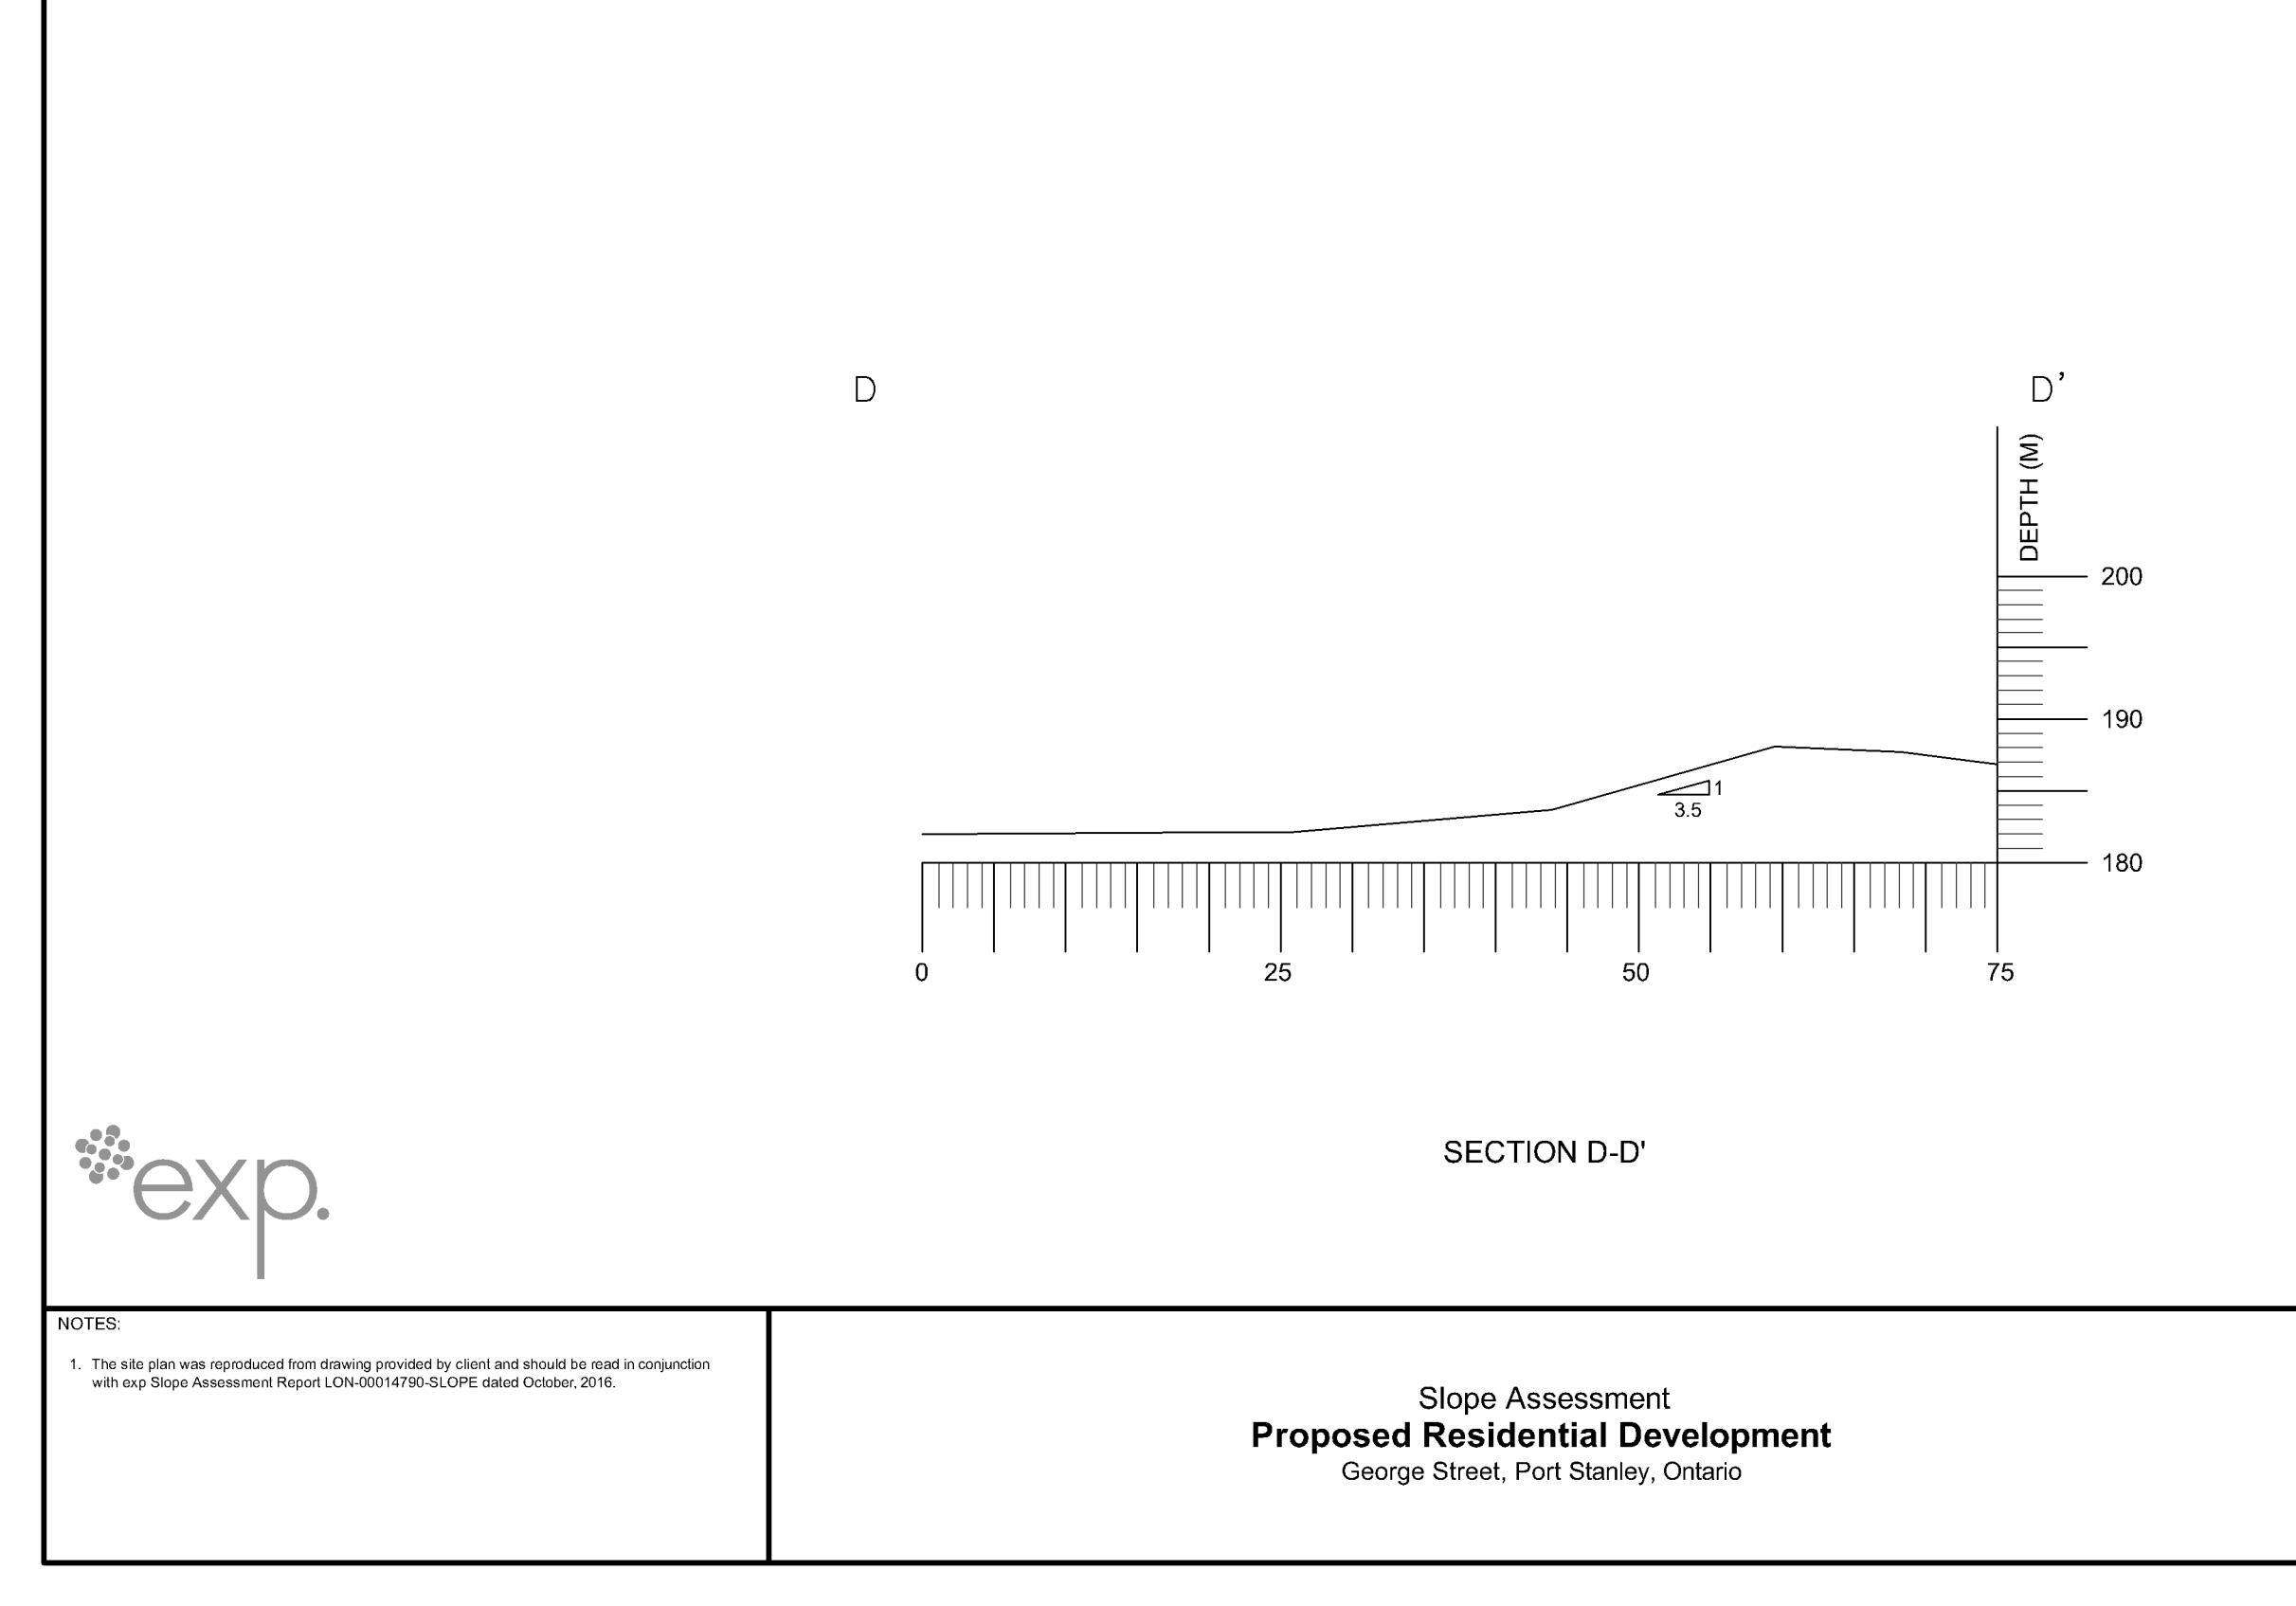
a	.ent	387476 Ontari	o Ltd.			
٦	TLE	SECTION D-D	,			
D	awn by	J.T.		REVE	HED BY I.S.	
	[*] e	xp.	15701 Robin	's H	exp Services Inc. ill Road, London, ON, N5V 0A5	
D	Ju	ne 2017	scale 1:500		PROJECT NO. LON-00014790-GE	^{DWG.} 205

To confirm there is no an issue with a slope located on the east side of the site (Area "2"), one cross section, designated as Section D-D, was drawn across the steepest section of this slope. The cross section is shown on the Drawing 1. Based on the profile of Section D-D, the slope inclination was 3.5H:1V and flatter with approximate height ranging from 2.5 to 3.0 m. The slope has a gentle inclination and low height. Based on the above, no setback is required at this zone and no further recommendations are needed.
