**GEOTECHNICAL INVESTIGATION  
PROPOSED RESIDENTIAL DEVELOPMENT  
384 George Street  
Port Stanley, Ontario**

November 3, 2022

**File No.:** G22383

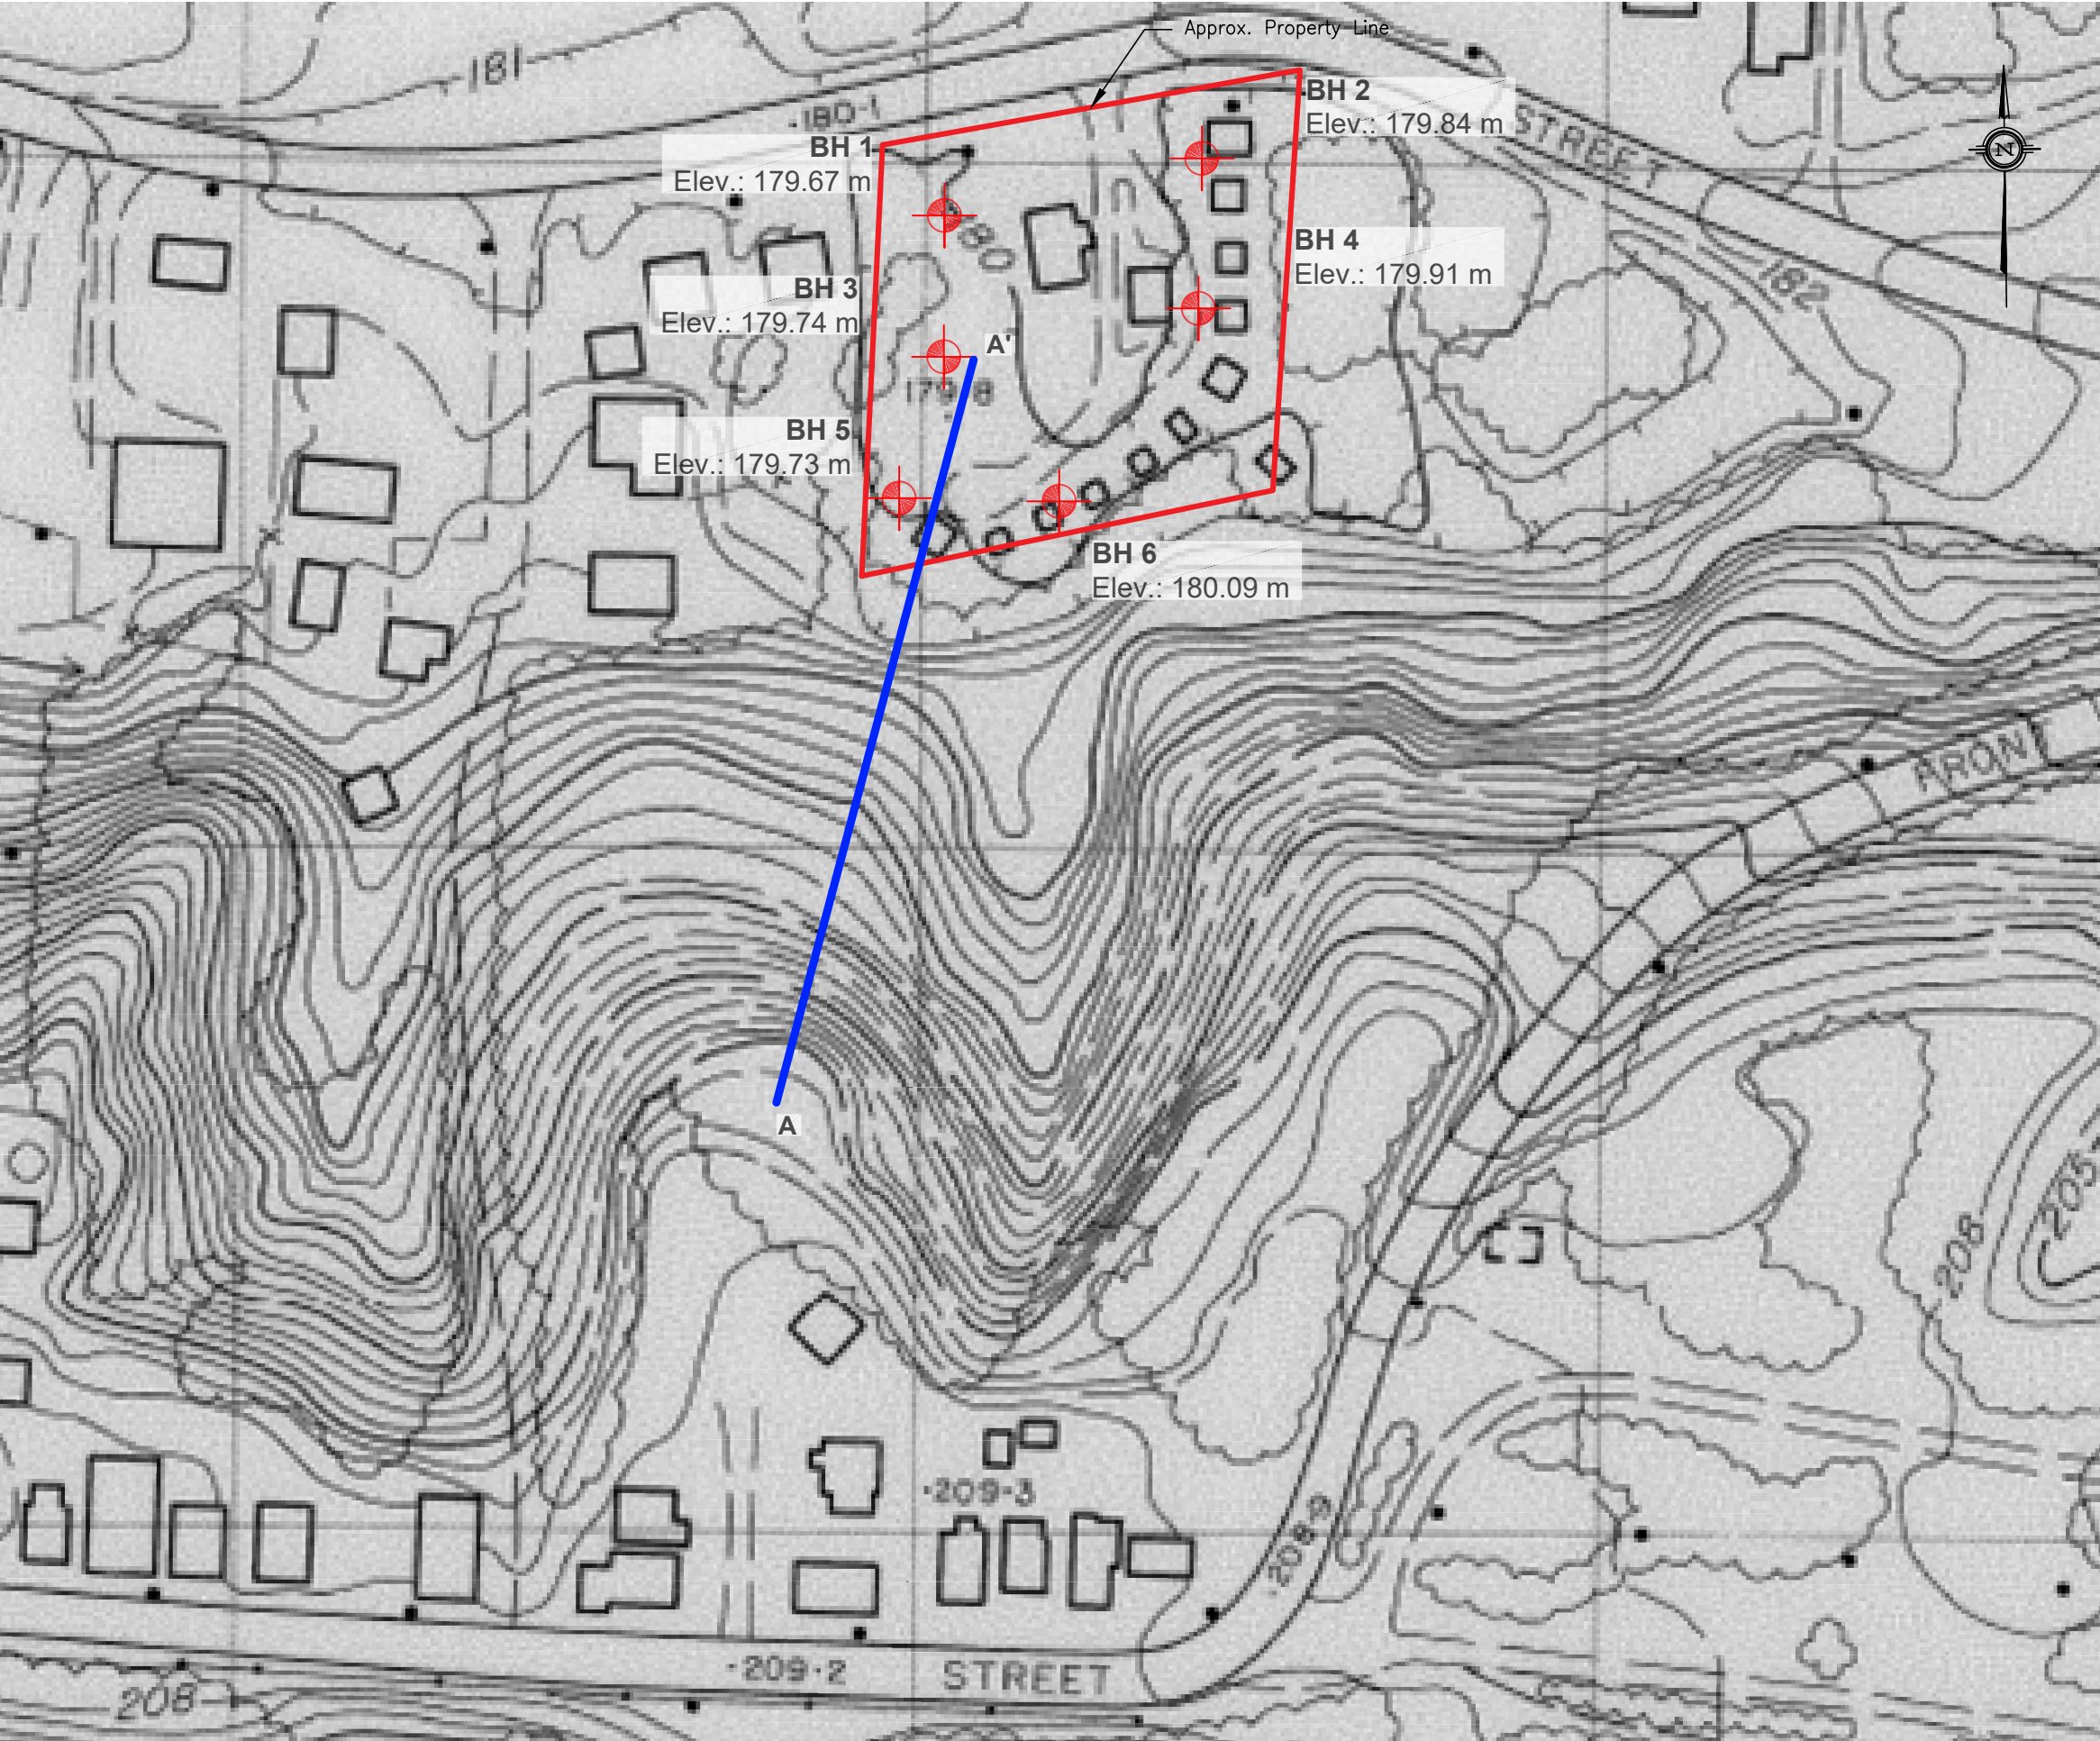
### **BOREHOLE AND SLOPE SECTION LOCATION PLAN**

Six (6) boreholes were advanced to depths between 6.55 and 9.15 m below existing grade on February 22, 2022. The borehole locations are illustrated on the Borehole Location Plan, Drawing No. 1, appended.

A representative slope condition (Section A-A' in Appendix B) was selected from the existing slope to perform a slope stability analysis. The soil parameters used in the slope stability analysis were determined based on the field and laboratory test results of the present investigation and our experience with similar soil types. The selected "effective stress - drained condition" soil parameters and groundwater condition were used to perform the stability analyses with the use of modeling software Slide.

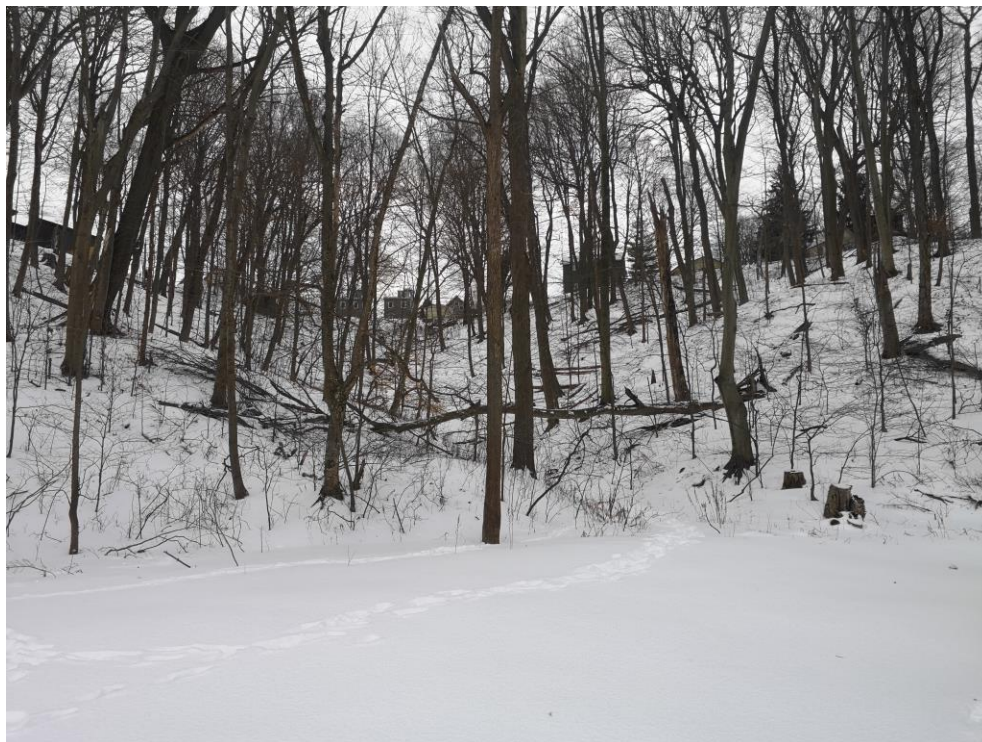
A natural slope is located at the southern (rear) portion of the property. A slope condition reconnaissance/inspection was carried out on February 8, 2022 during the process of completing the private locates. The slope surface was fully covered by snow at the time of site reconnaissance. However, mature trees and shrubs were observed on the slope surface. Most of the trees were noted to be growing vertically, indicating minimal past slope instability. Selected photographs of the site and slope condition are shown in Appendix D.

Central Portion of the Existing Slope

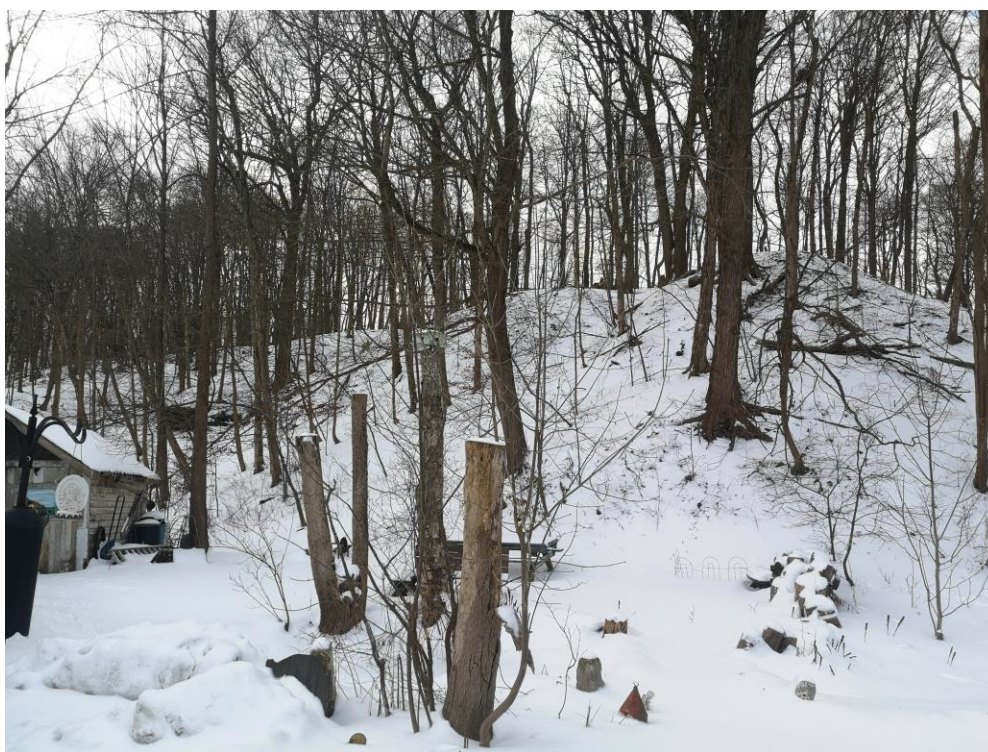
Eastern Portion of the Existing Slope (based on true north direction)

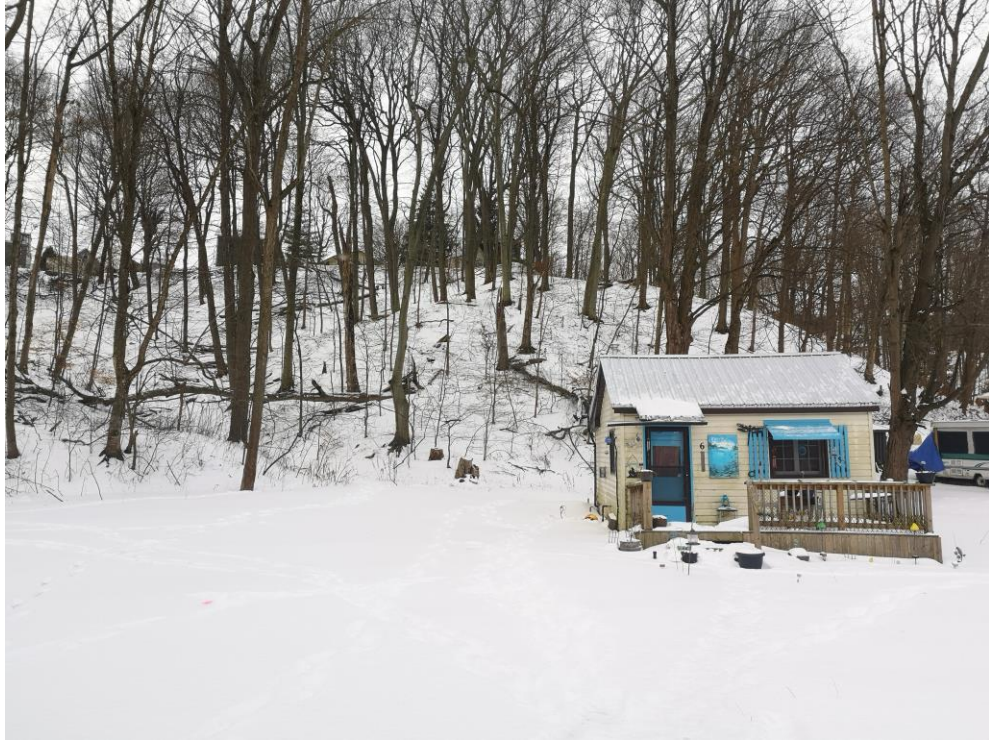
Western Portion of the Existing Slope (based on true north direction)

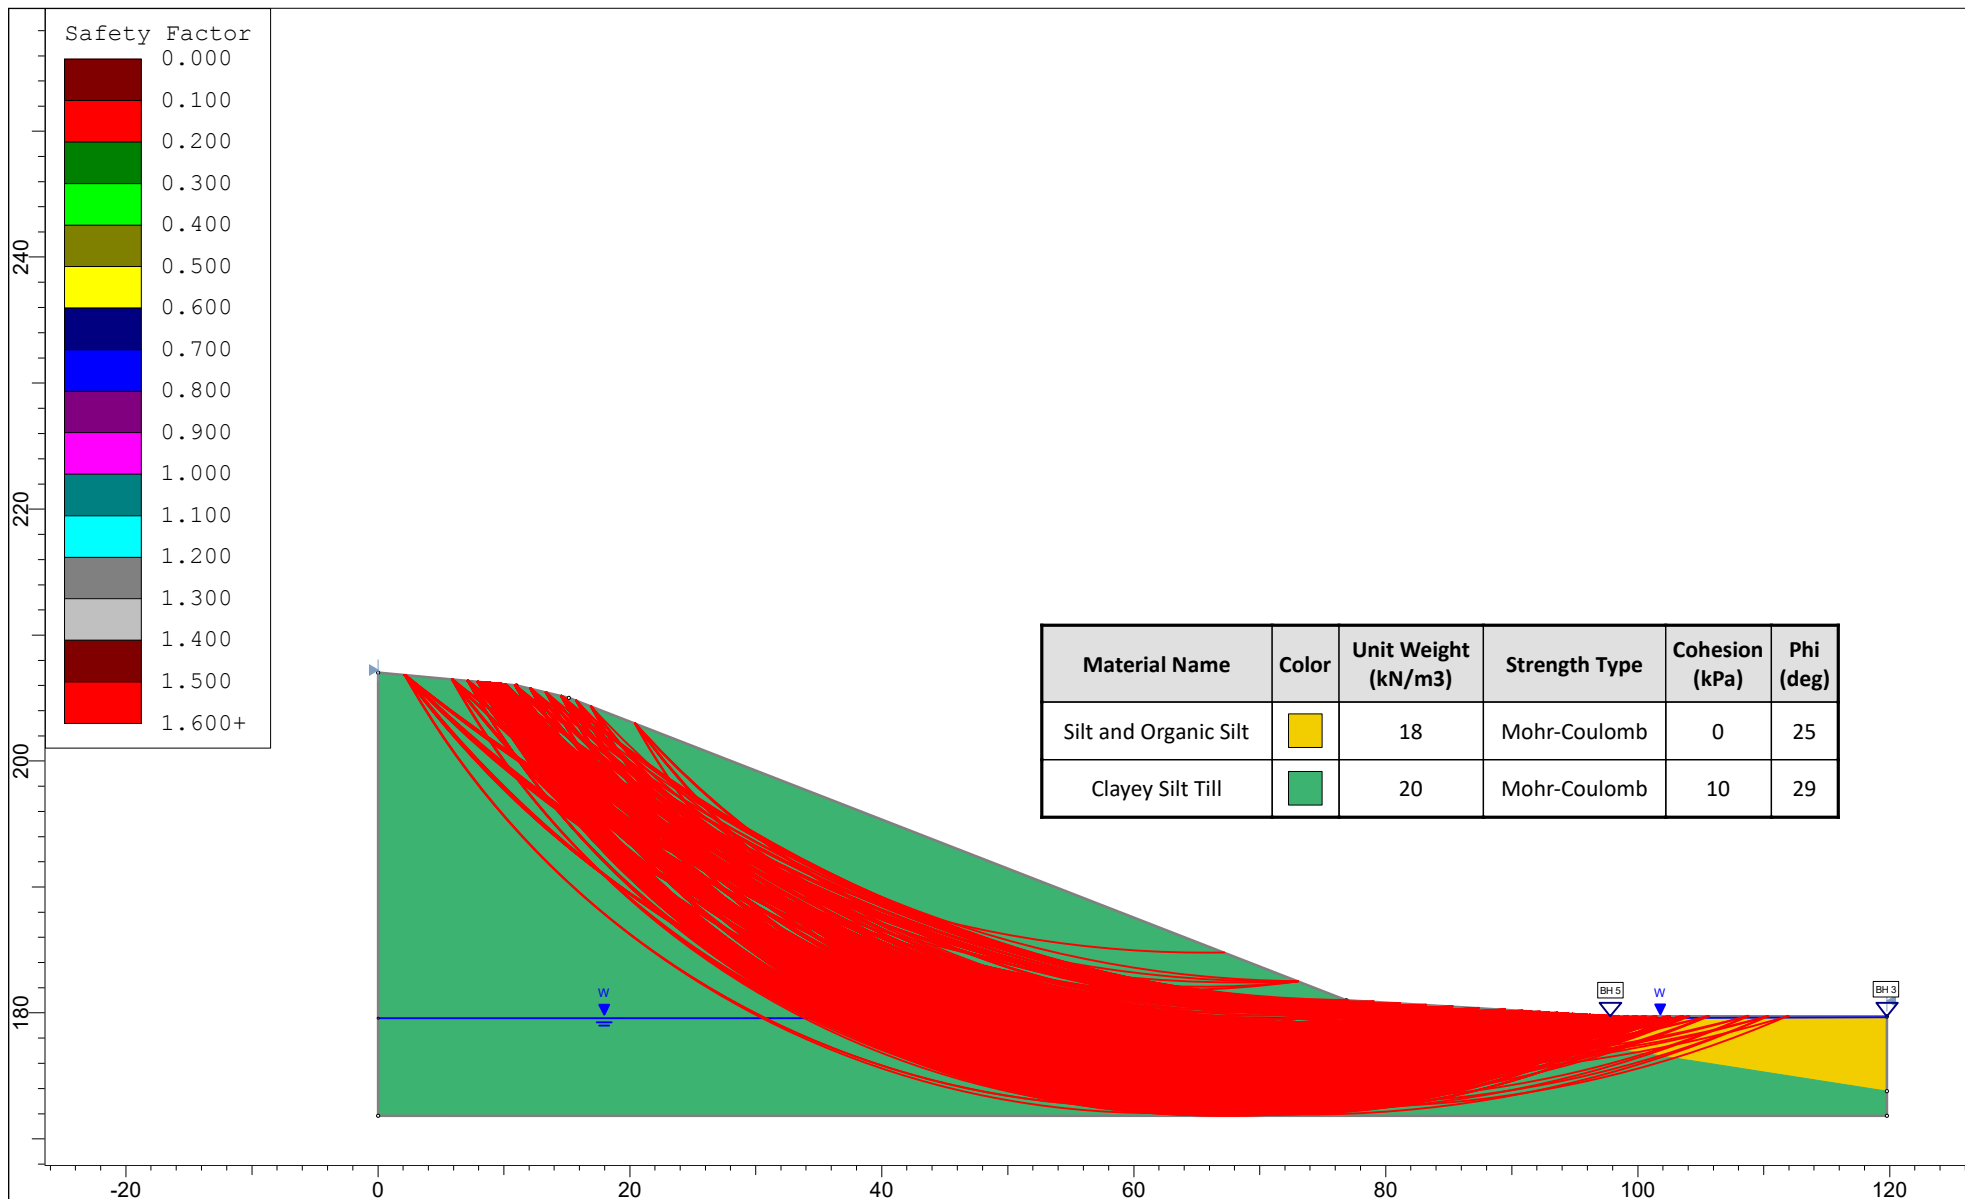
Project				
	G22383 - Slope Stability Assessment				
	Analysis Description				
Drawn By		NZ	Scale	1:600	Company
					CVD
Date			File Name		
October 28, 2022			Figure No. 1

Soil Type	Unit Weight (kN/m <sup>3</sup> )	Friction Angle ( $\phi^0$ )	Cohesion (C', kPa)
very soft to firm/loose Silt and Organic Silt	18	25	0
stiff to hard Clayey Silt Till	20	29	10
