TREE ASSESSMENT AND PROTECTION

**Doug Tarry Homes Ltd.
St. Thomas**

June 2021

APPENDIX 5: Tree Hazard Assessment for Northern Ravine

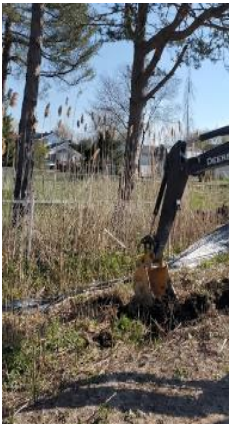
13	White Spruce (<i>Picea glauca</i>)	Boundary	N/A	N/A	a,b	A	No new shoots, roots exposed 1 m from bole (fewer than Maple to the S). Crown decline, requires proper pruning	at dripline

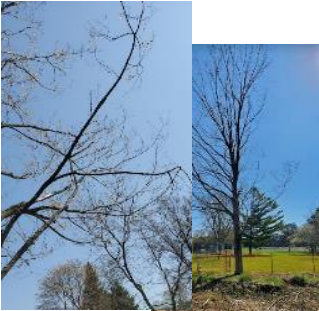
19-22	19 & 20: White Pine (<i>Pinus strobus</i>) . 21 & 22: Sugar Maple	Boundary	N/A	N/A	a,b,c	A,B	few Thumb thick roots at previous stripping limit /dripline	At dripline

(<i>Acer saccharum</i>).								
23	Tulip Tree	Boundary	N/A	N/A	a,b,c	A,B	tons of large roots 2 inch thick dug up in previous earth work.. Tree may be a hazard..	beyond dripline

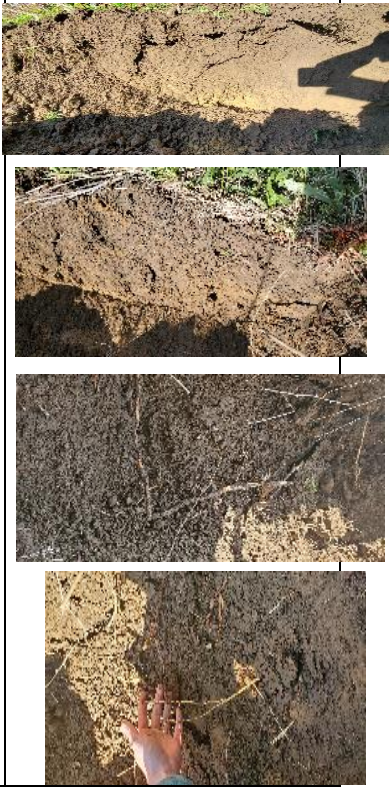
28	White Pine (<i>Pinus strobus</i>)	Beyond site	0	at dripline	a	A	Pit at dripline/property line. Minor roots, all good.	property line

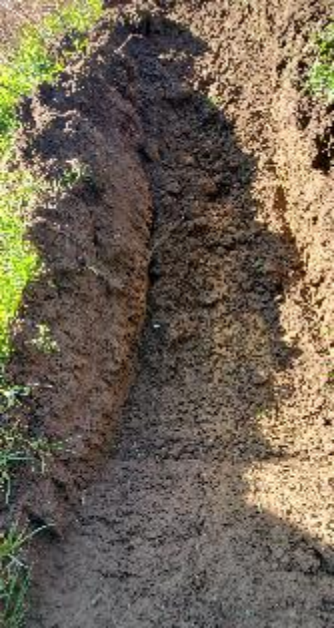
29	Silver Maple (<i>Acer saccharinum</i>)	Beyond site	0	at dripline	c	A	Don't see more than pencil roots at dripline from previous stripping. Pit at property line, 1 root, all good.	property line

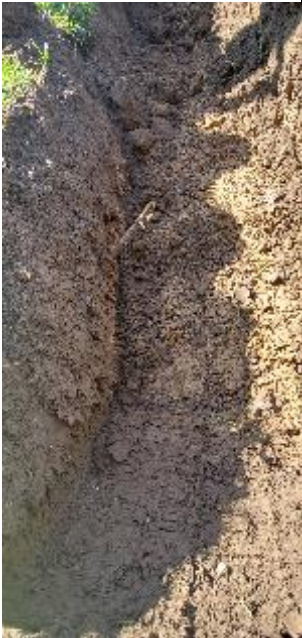
34	White Cedar (Thuja occidentalis) hedgerow	boundary	N/A	3.45 from base, at dripline	a,b,c	A	Cedar hedge row. Pit at dripline, few thumb+ roots.	at dripline
